HAZARDOUS MATERIALS INVESTIGATION REPORT

**MAIN BUILDING (2515) & GARAGE (2535)
CAMBRIA COMMUNITY HEALTHCARE DISTRICT
2515 MAIN STREET
CAMBRIA, CA 93428**

AUGUST 17, 2021

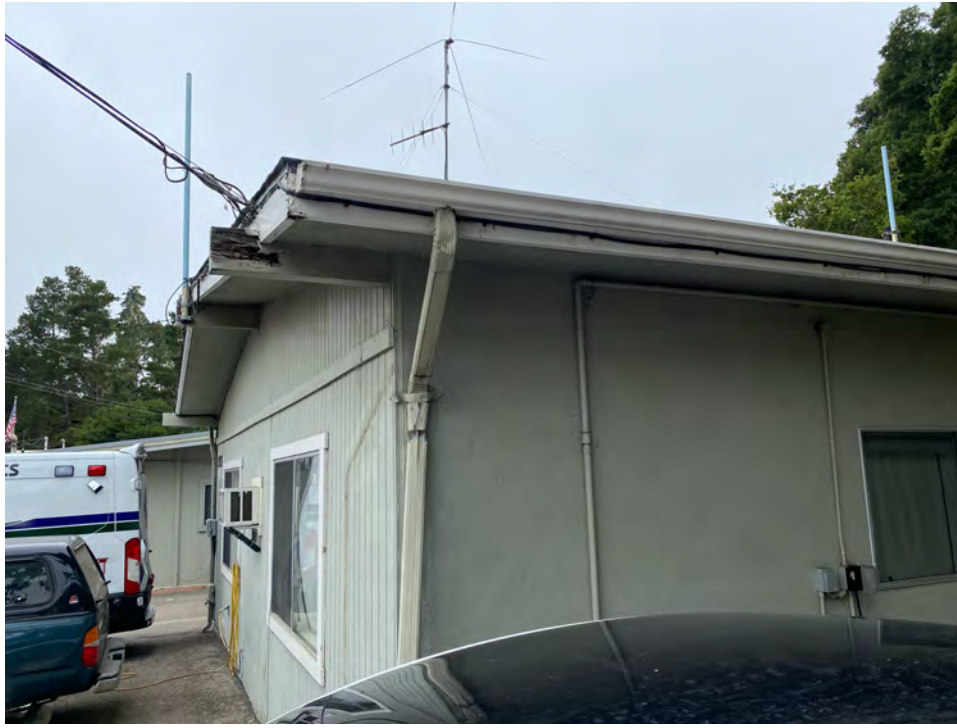
Sample	Location	Type of Material	Level of Lead	Condition
L-01	Exterior	Gray Wood Beam	0.10%	Poor
L-02	Exterior	White Wood Fascia	0.15%	Good- Fair
L-03	Exterior	White Wood Door Casing	0.098%	Good

**Photo 13- Gray Wood Beam & White Wood Fascia & Window-Mounted Air Conditioner
2535 Main St.- Exterior- Lead-Containing Paint & Refrigerant (Good- Poor Condition)**

There is a window-mounted air conditioning unit in the garage that has coolant that should be properly discharged.
