# **HAZARDOUS MATERIALS INVESTIGATION REPORT**

**MAIN BUILDING (2515) & GARAGE (2535)  
CAMBRIA COMMUNITY HEALTHCARE DISTRICT  
2515 MAIN STREET  
CAMBRIA, CA 93428**

**AUGUST 17, 2021**

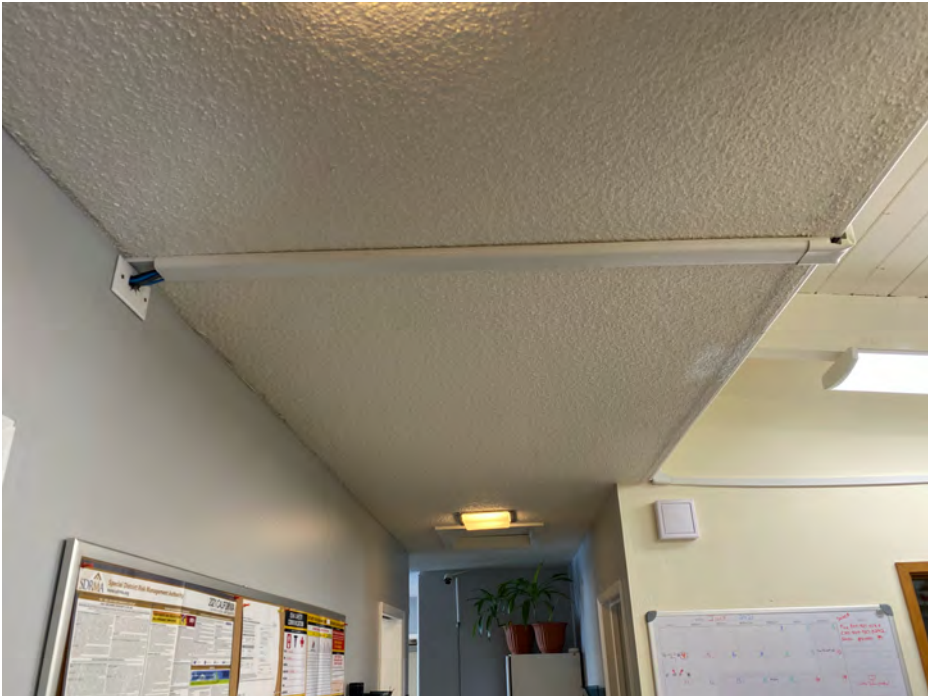
**Photo 1- Spray-Applied Acoustic Ceiling Material & Joint Compound  
Assoc. w/ Drywall Walls & Ceilings- 2515 Main St.- CCHD Office Area- ACM**

ACM was in overall good condition at the time of the survey. McKenna Environmental, Inc. recommends that all future activities that could disturb the ACM, including renovation or demolition, be performed by properly trained personnel. These activities should employ state-of-the-art techniques and be performed in accordance with all local, State, and Federal laws and regulations.

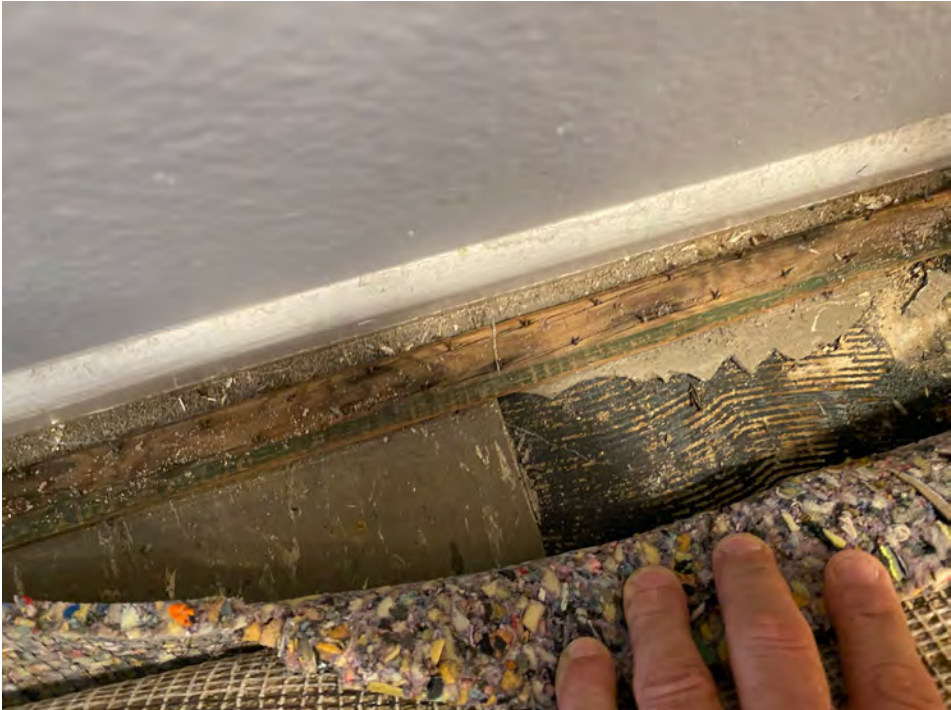
**Photo 2- Gray 9" x 9" Floor Tile (Under Carpet & Sheet Flooring)-  
2515 Main St.- CCHD Office Area- ACM**

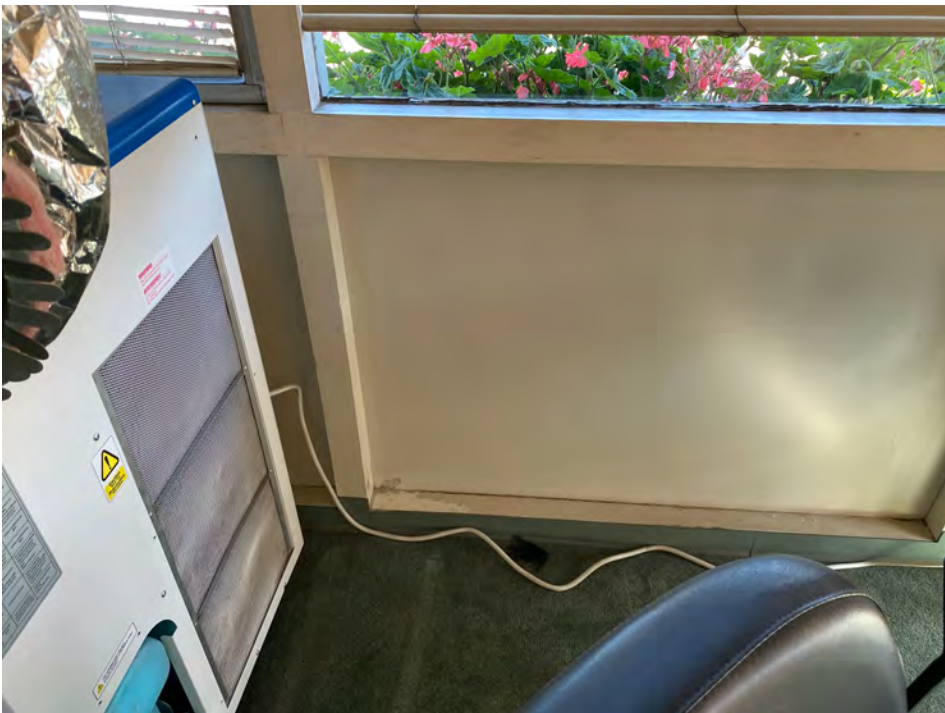
**Photo 4- Transite Window Panels & White Wood Window Casing (Interior)-  
2515 Main St.- CHC Waiting Room/ Exterior- ACM LBP (Good Condition)**

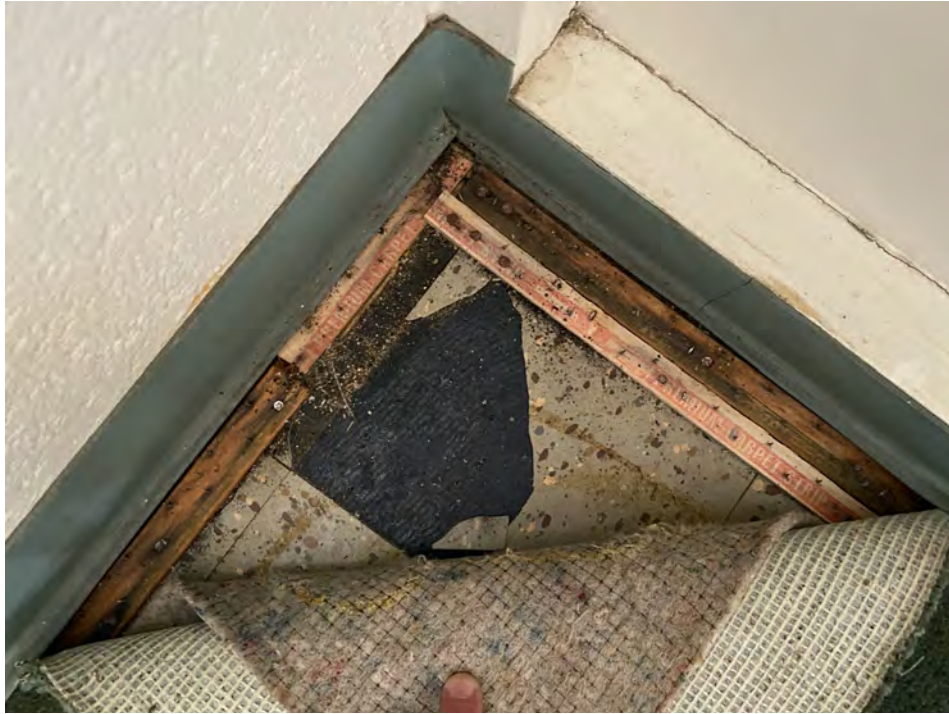
**Photo 5- Gray Speckled 9" x 9" Floor Tile & Black Mastic (Under Carpet)-  
2515 Main St.- CHC Office Area- ACM**

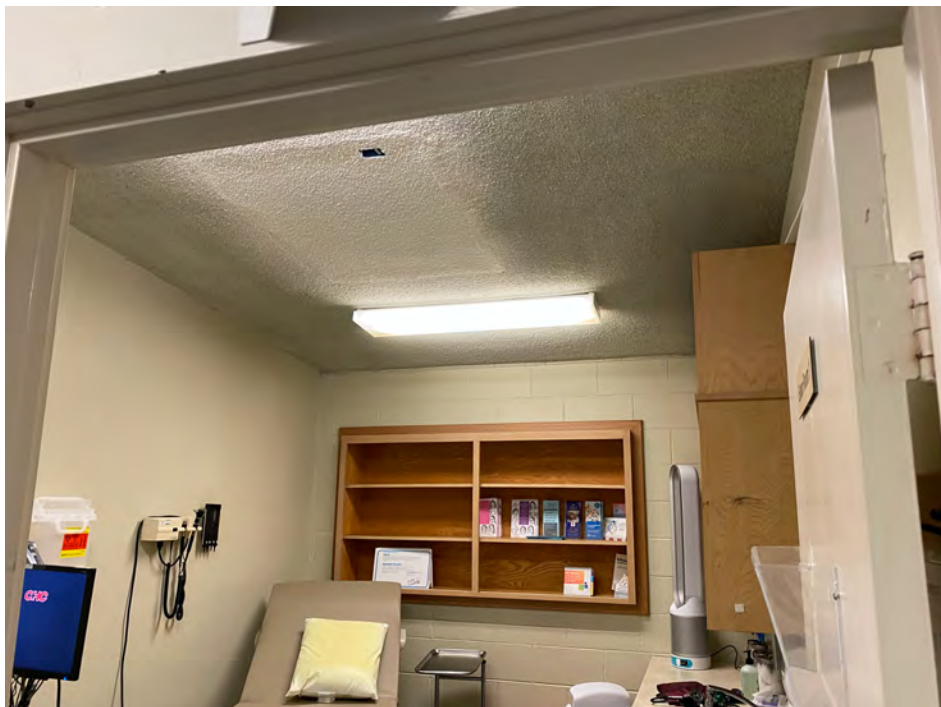
**Photo 6- Spray-Applied Acoustic Ceiling Material- CHC Office Area- ACM**

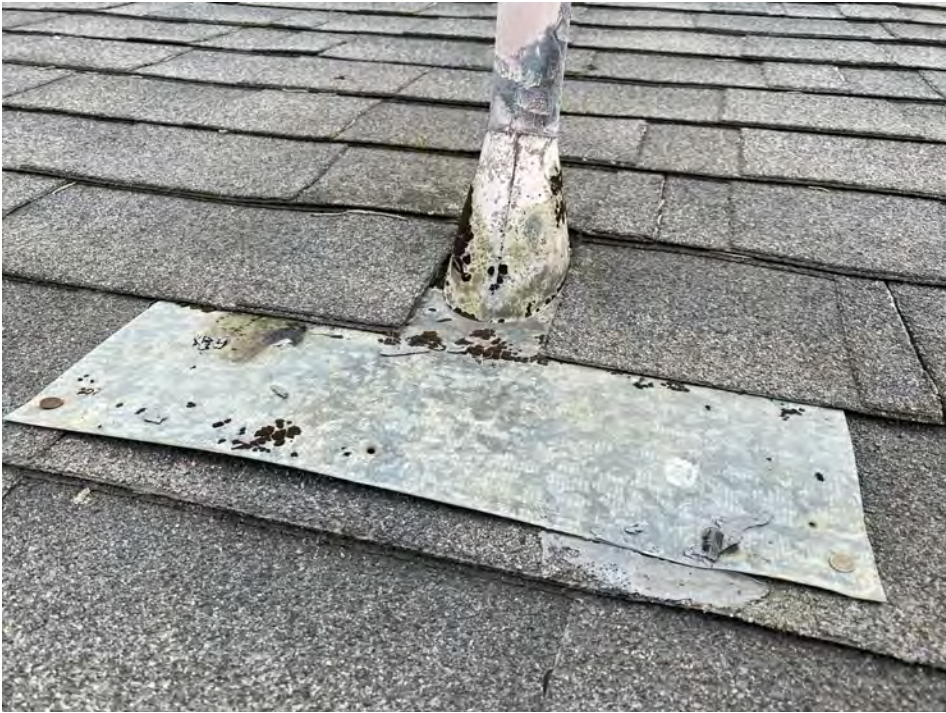
Sample(s)	Location	Type of Material	Level of Asbestos	Quantity	Friability	Condition
04, 05 & 06	Penetrations Throughout Roof	Roofing Mastic	10% Chrysotile	10 SF	Non-friable	Good

**Photo 7- Roofing Mastic- 2535 Main St.- Penetrations Throughout Roof- ACM**

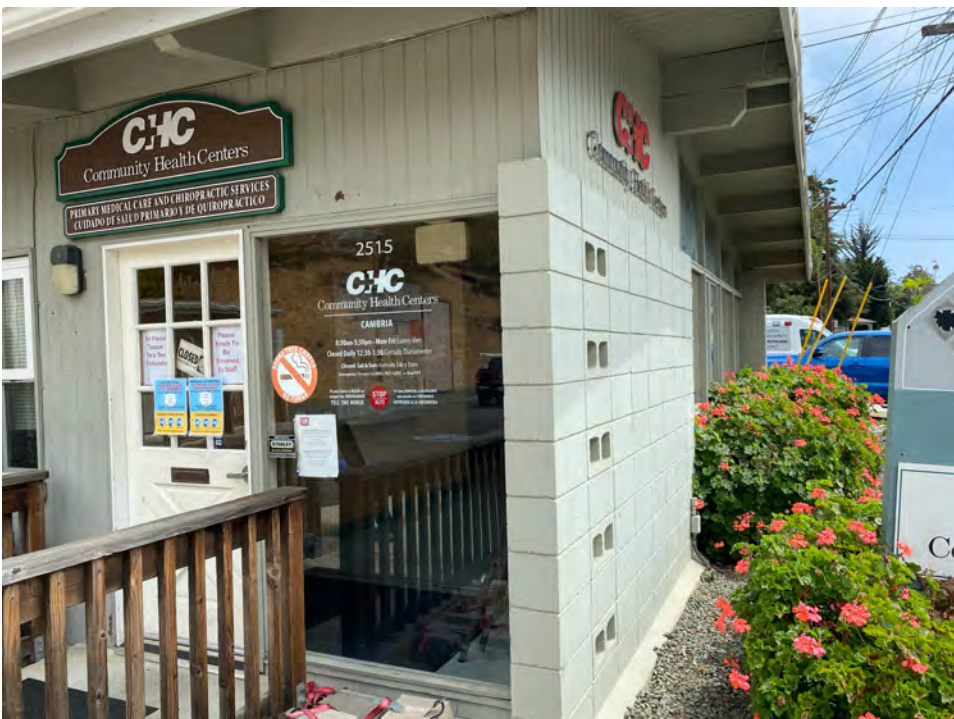
**Photo 8- Gray Wood Window Casing/ Sill & Gray Wood Siding- 2515 Main St.- Exterior- LBP & Lead-Containing Paint(Poor Condition)**

Detectable amounts of lead were found throughout the interior and exterior of the buildings. Confirmed lead-containing paint and LBP were in overall good to poor condition at the time of the survey. McKenna Environmental, Inc. recommends that all future activities that could disturb the lead-containing paint, including renovation or demolition, be performed by properly trained personnel. These activities should employ state-of-the-art techniques and be performed in accordance with all local, State, and Federal laws and regulations.

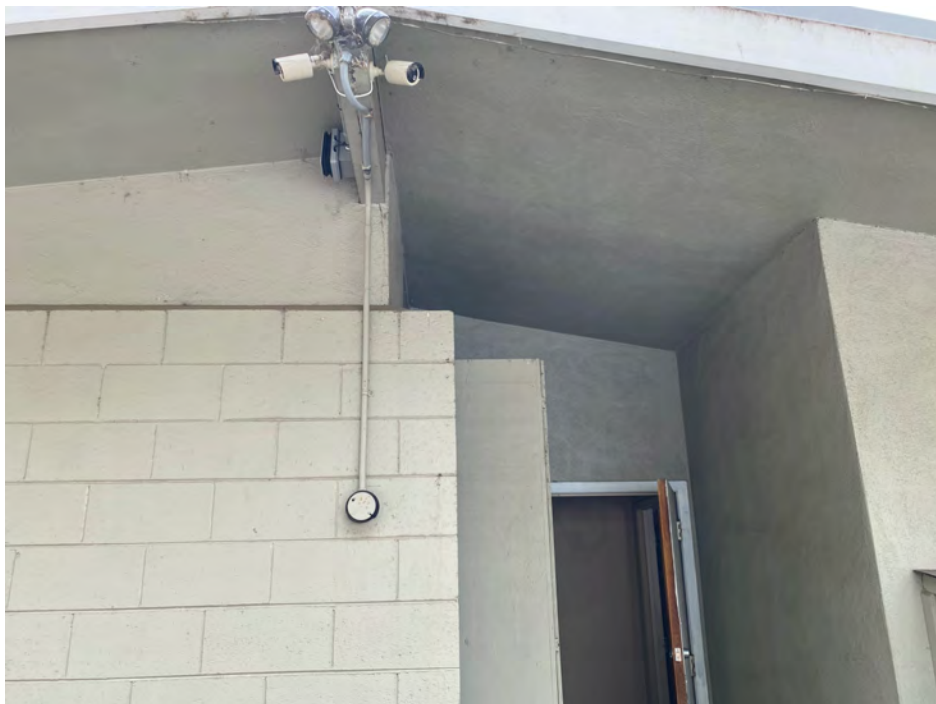
**Photo 10- White Wood Fascia- 2515 Main St.- Exterior-  
Lead-Containing Paint (Good Condition)**

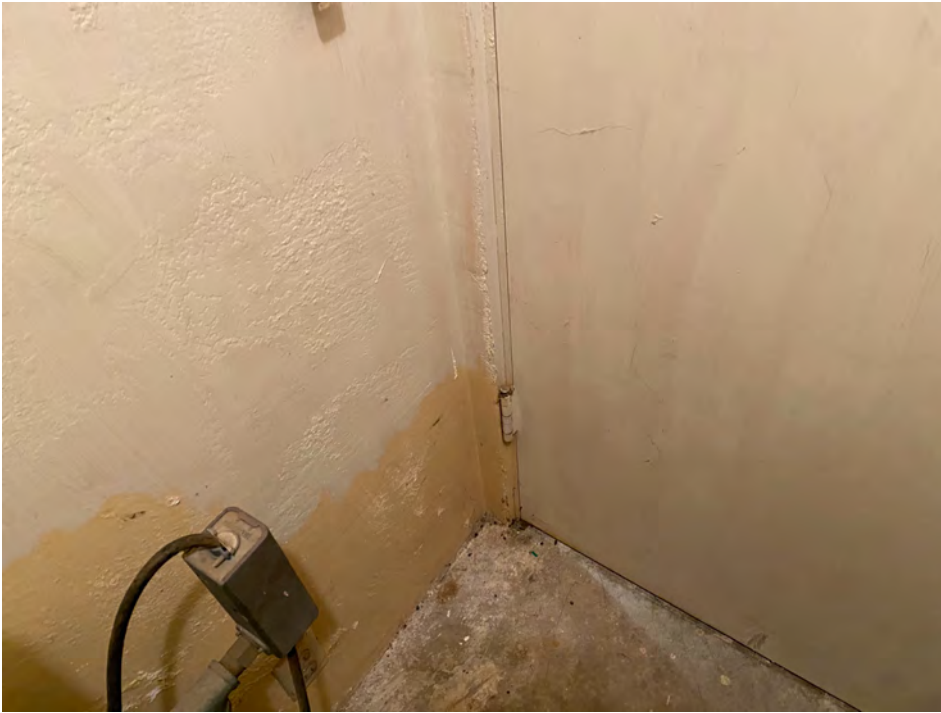
**Photo 11- White/ Yellow Plaster Wall- 2515 Main St.-  
CHC Area- Lead-Containing Paint (Good Condition)**

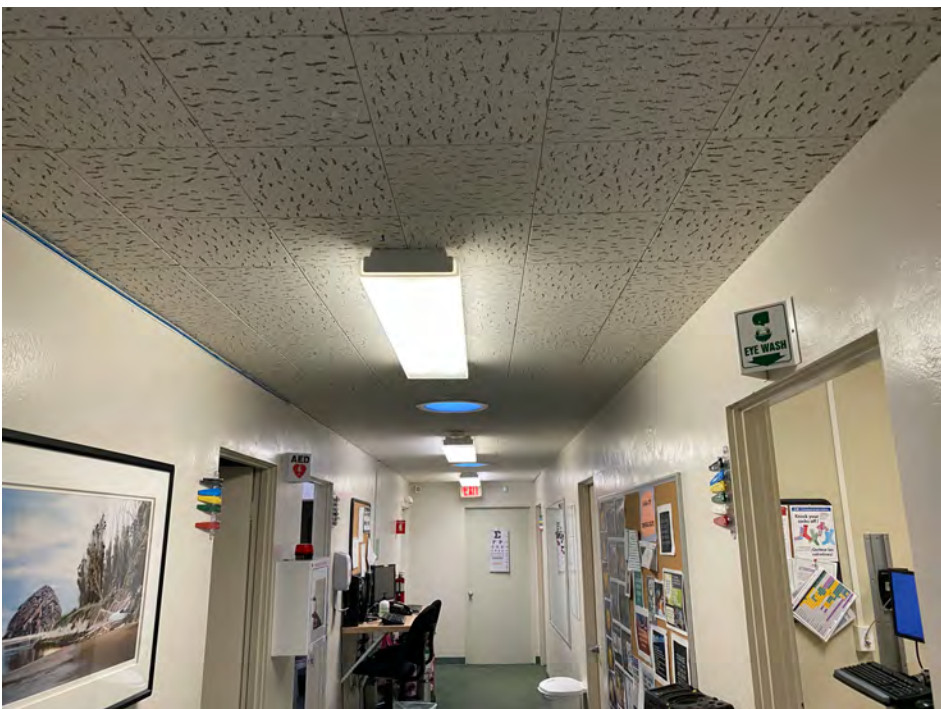
**Photo 12- White Plaster Walls, White Wood Door & Casing- 2515 Main St.-  
CHC Area- Lead-Containing Paint & LBP (Good Condition)**

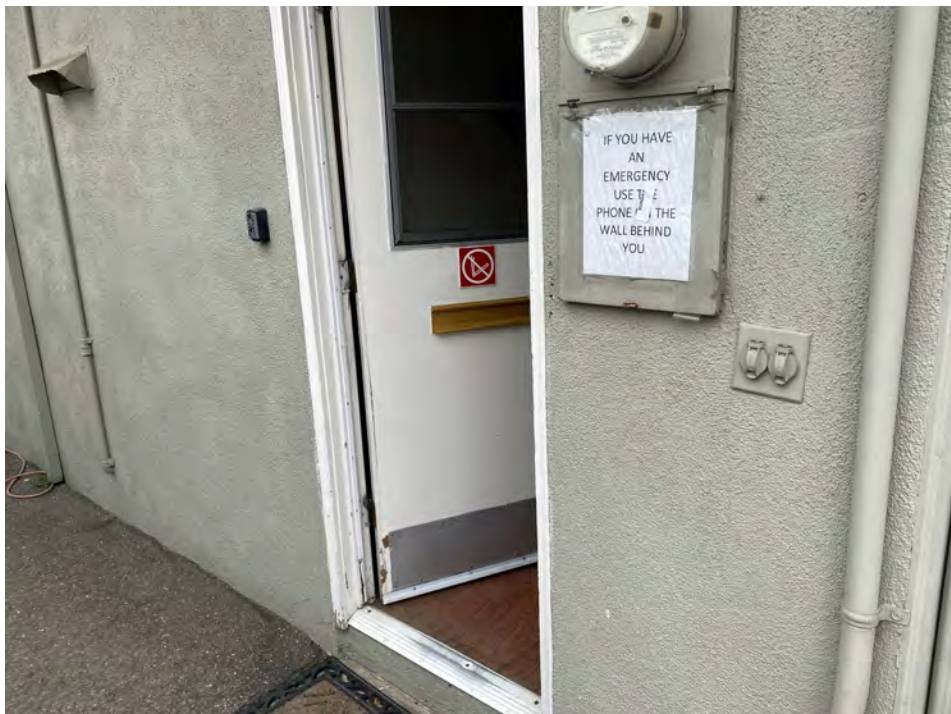
**Photo 14- White Wood Door Casing- 2535 Main St.- Exterior-  
Lead-Containing Paint (Good Condition)**

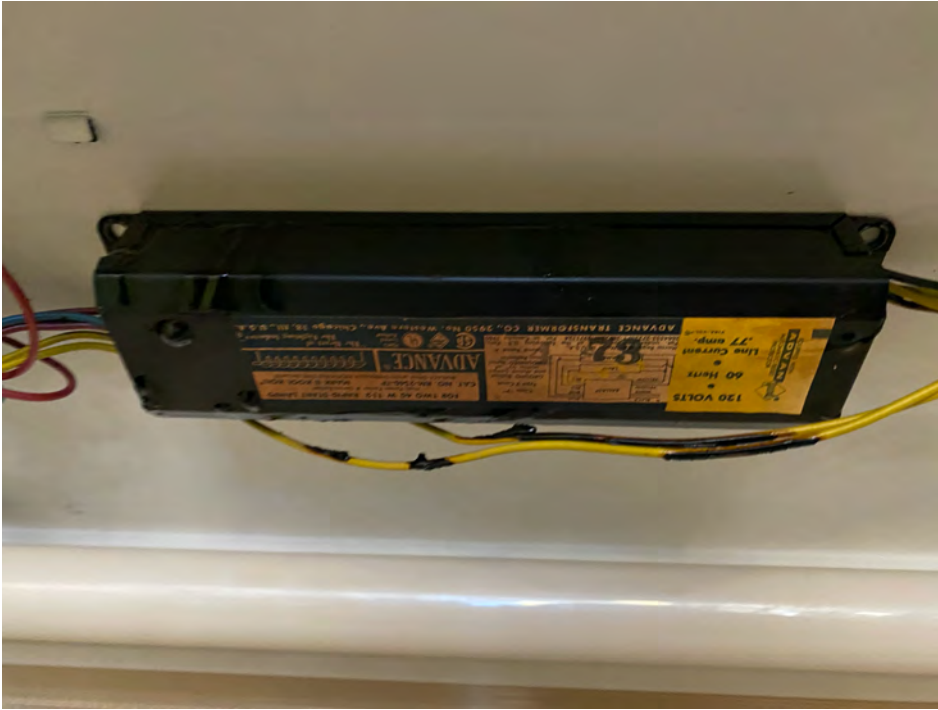
**Photo 15- PCB Ballasts in Light Fixtures- 2515 Main St.- Throughout Area**

In the buildings several labels on the light ballasts visually inspected indicated that PCBs were contained in some of the ballasts in the main building. There are 5 PCB ballasts in 4 light fixtures in total. These ballasts should be removed and disposed of safely.

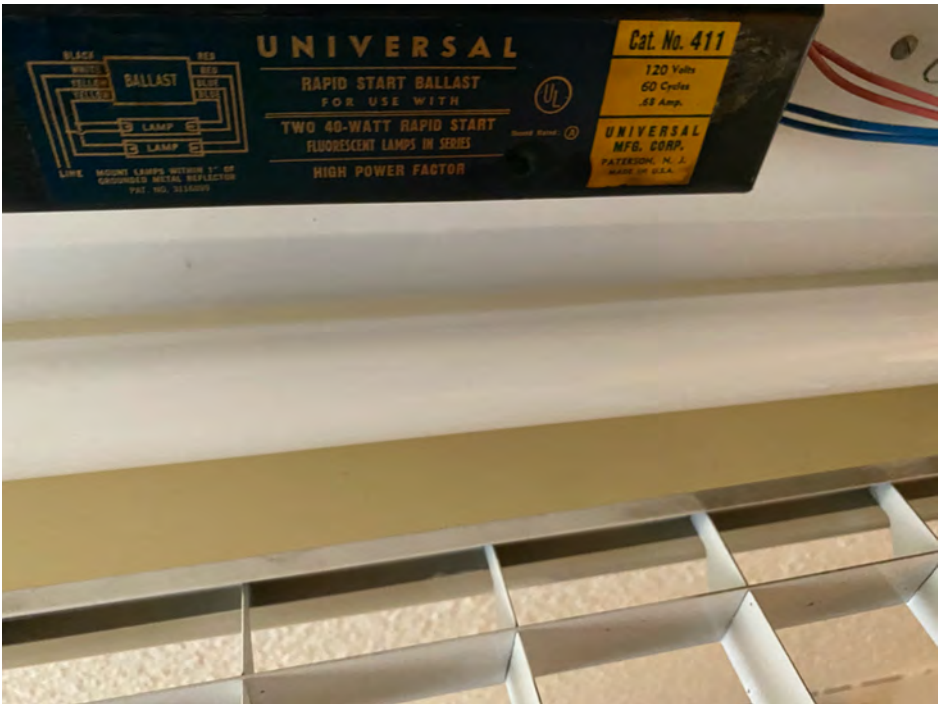
**Photo 16- Mercury-Containing Light Tubes in Light Fixtures-  
2515 & 2535 Main St.- Throughout Area**

The light fixtures are 4 feet long and have mercury containing light tubes. There are 2 light tubes in the garage and 62 light tubes in the main building in total. These light tubes should be carefully removed, containerized in cardboard boxes and recycled properly.
