Cambria Community Healthcare District
Ambulance Station/Administrative Offices
Pre-Design Services

January 25, 2022

Cambria Community Healthcare District Feasibility Study

Facility Condition Assessment
Final January 25, 2022

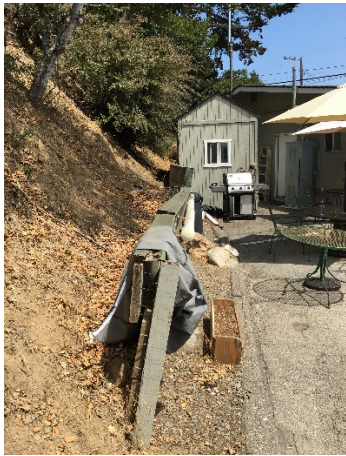
- Site Improvements and Site Utilities – Site lighting is poor, proper drainage away from the building is not provided, some areas of the existing debris wall have failed, some paved areas are in poor condition.

Failing debris wall

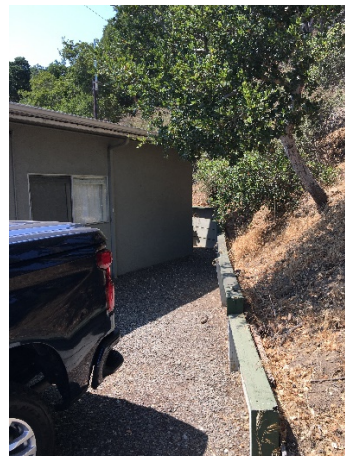
Debris wall behind facilities

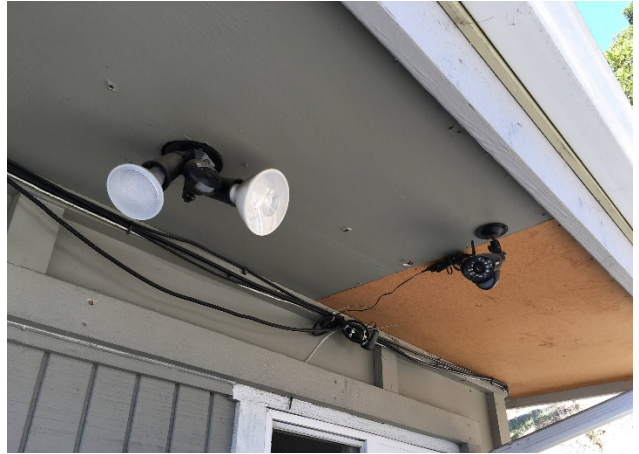
Soffit detail

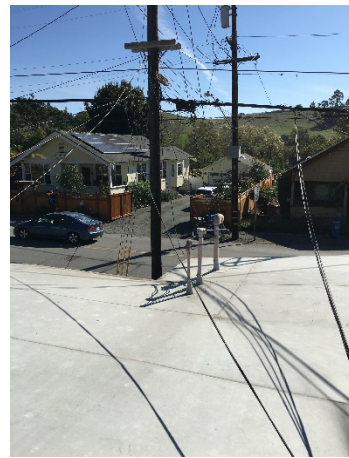
Newer Roofing

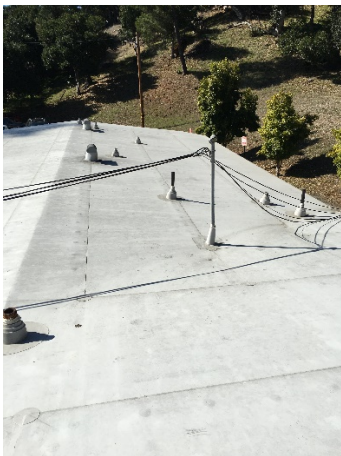
Newer Roofing

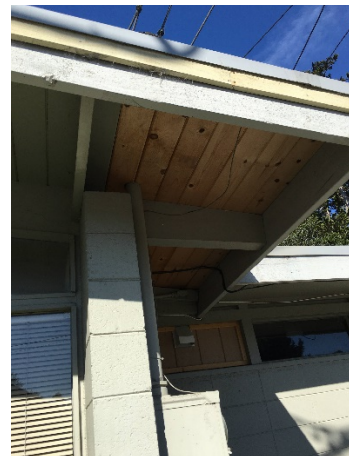
Soffit detail

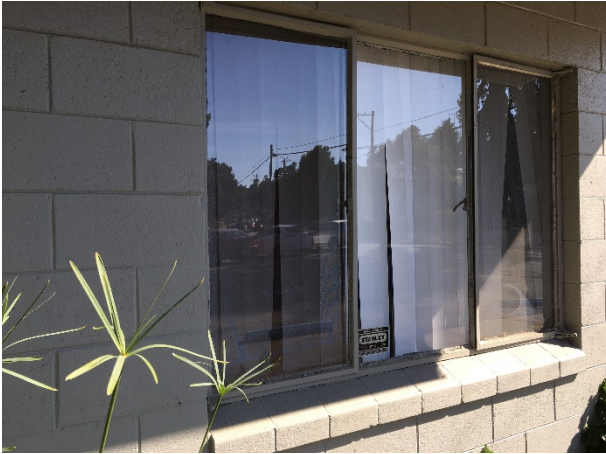
Window doesn't close properly

- **Exterior Envelope.** All windows, storefront entry systems, doors, and hardware are beyond useful life and should be replaced. The roof is a newer single ply membrane in good condition with approximately ten years of life remaining. Some wood siding has moisture damage; unless grading conditions at exterior walls are improved it is likely damage will continue.

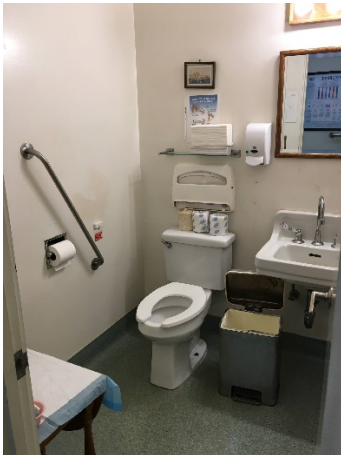
Non-ADA restroom

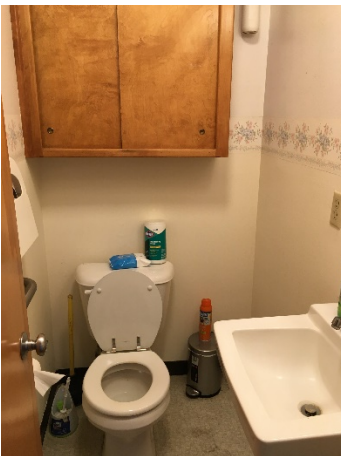
Non-ADA restroom

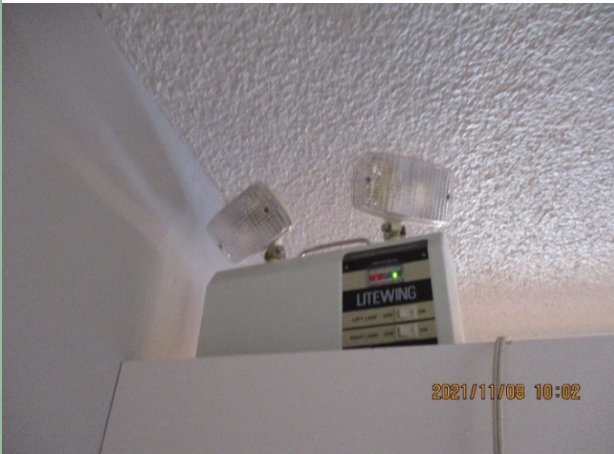
Emergency lighting

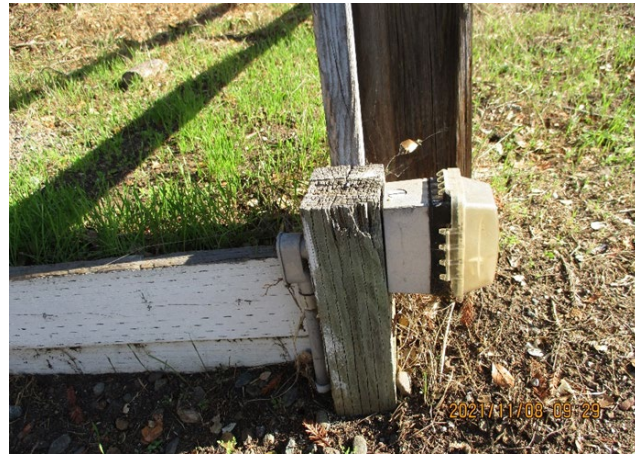
Non-compliant exterior outlet

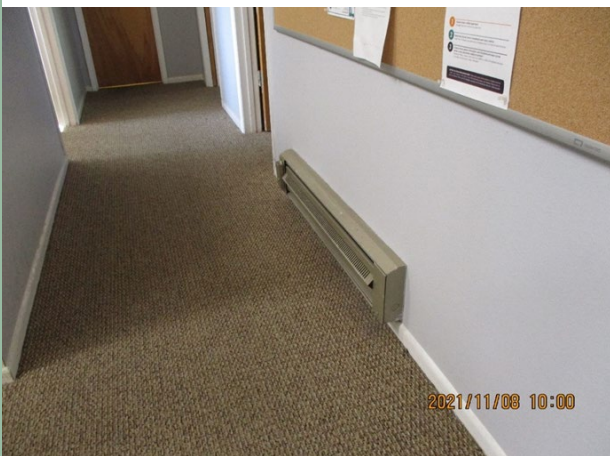
Non-working wall heater

- **Plumbing, HVAC, and Electrical.** There are no functional heating, cooling, or ventilation systems in the facility. Nearly all mechanical, electrical, and plumbing systems appear to be original and are well beyond useful life (or missing) and should be replaced in their entirety.

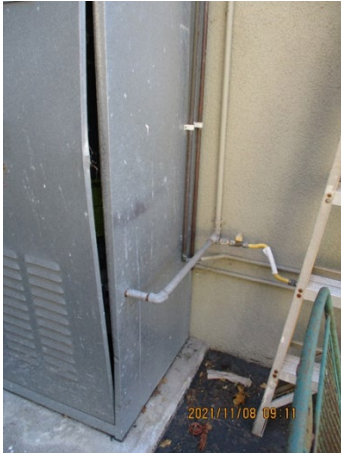
Non-compliant gas connection

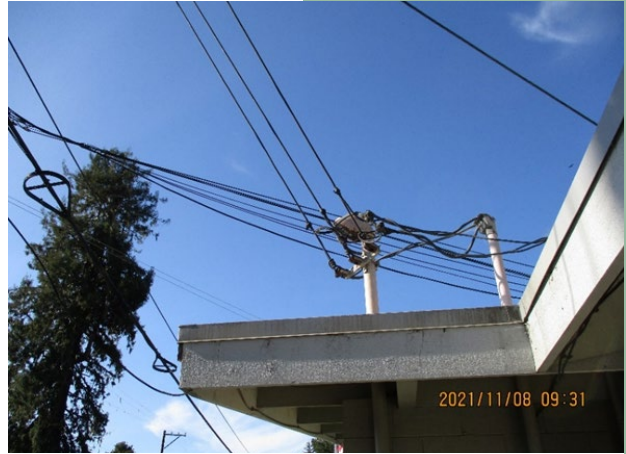
- The building power distribution wiring includes multiple service entrances rated at 120/240Volt 3-phase, 3-wire and associated non-compliant power distribution panels. Nothing short of a complete replacement of the entire system will fix this set of conditions.
- The whole building power system fails to meet the most basic requirements. Hot, neutral, and grounding and bonding issues - Service entrance to connected loads. Only a complete replacement of the system will resolve the variety of code violations and deficiencies.
- Suggest PG&E Utility to investigate and remove pole mounted single phase service laterals; an unacceptable

Electric service hodge-podge of wiring

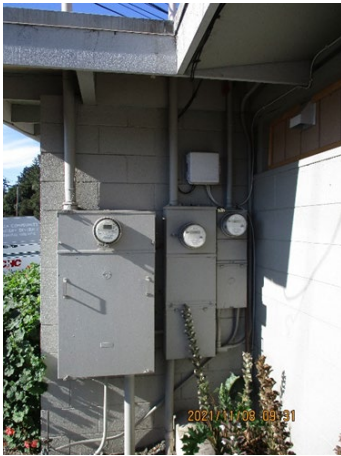
PG&E service nos. 1, 2, and 3

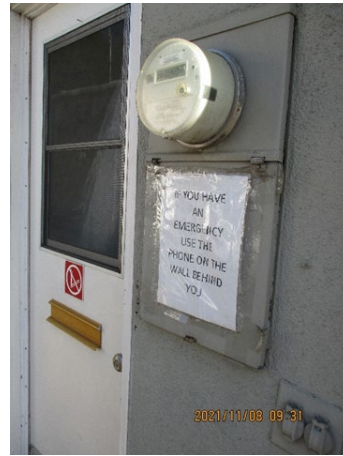
PG&E service no. 4

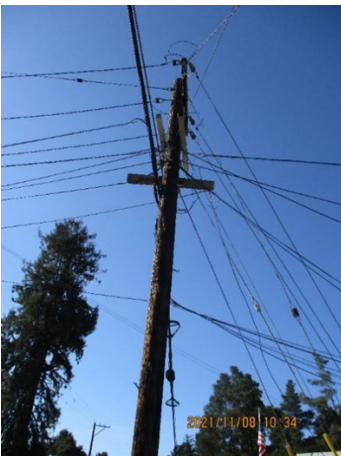
PG&E service pole

public safety condition - Recommend fast track resolution as soon as possible.

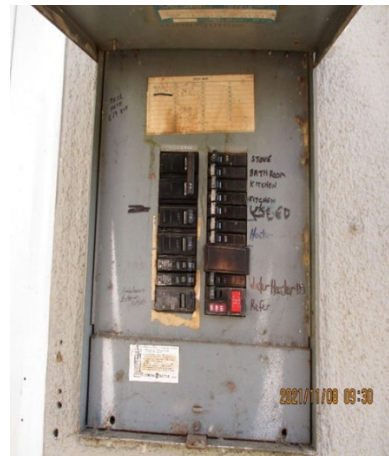
Electrical distribution panel
