HAZARDOUS MATERIALS INVESTIGATION REPORT

**MAIN BUILDING (2515) & GARAGE (2535)
CAMBRIA COMMUNITY HEALTHCARE DISTRICT
2515 MAIN STREET
CAMBRIA, CA 93428**

AUGUST 17, 2021

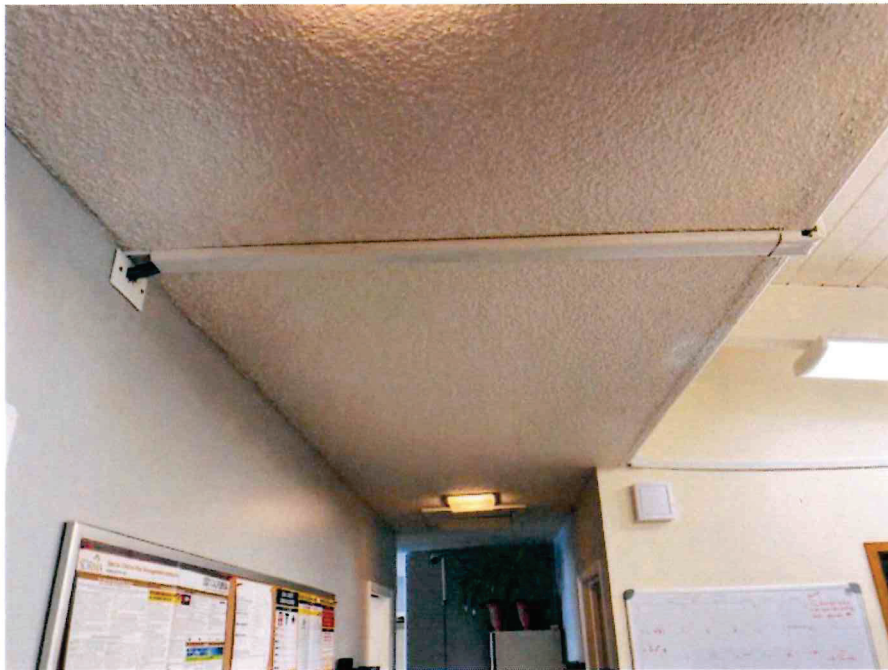
**Photo 1- Spray-Applied Acoustic Ceiling Material & Joint Compound
Assoc. w/ Drywall Walls & Ceilings- 2515 Main St.- CCHD Office Area- ACM**

ACM was in overall good condition at the time of the survey. McKenna Environmental, Inc. recommends that all future activities that could disturb the ACM, including renovation or demolition, be performed by properly trained personnel. These activities should employ state-of-the-art techniques and be performed in accordance with all local, State, and Federal laws and regulations.

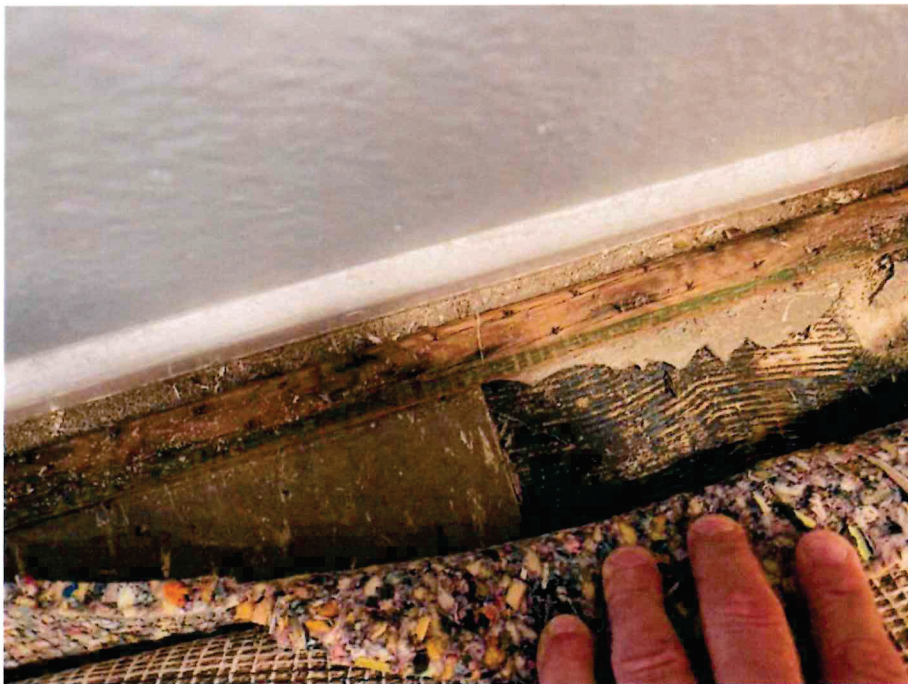
**Photo 2- Gray 9" x 9" Floor Tile (Under Carpet & Sheet Flooring)-
2515 Main St.- CCHD Office Area- ACM**

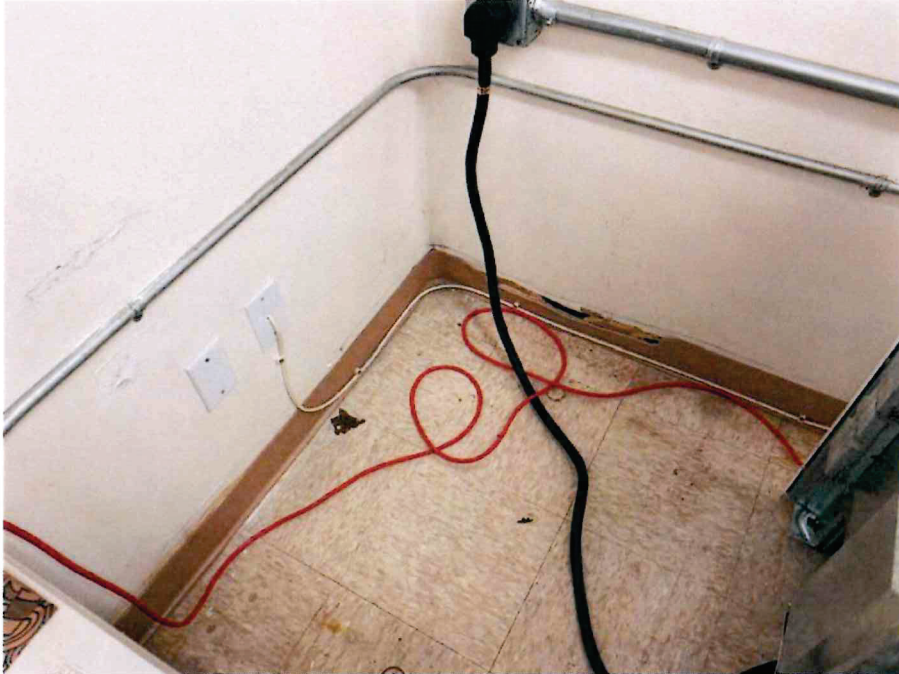
**Photo 3- Joint Compound Assoc. w/ Drywall Walls & Ceilings-
2515 Main St.- Ambulance Service/ Quarters- ACM**

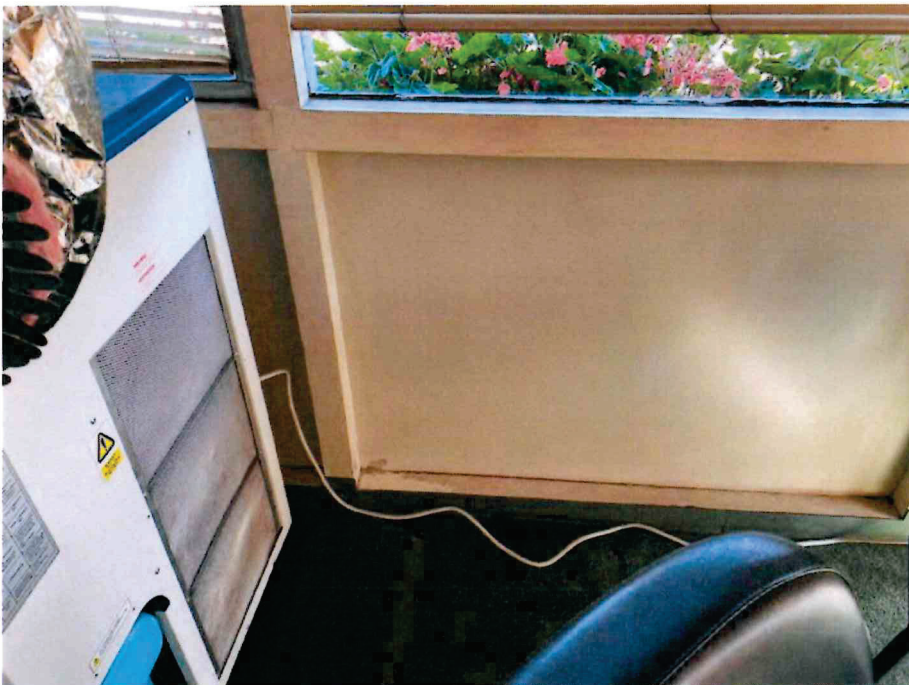
**Photo 4- Transite Window Panels & White Wood Window Casing (Interior)-
2515 Main St.- CHC Waiting Room/ Exterior- ACM LBP (Good Condition)**

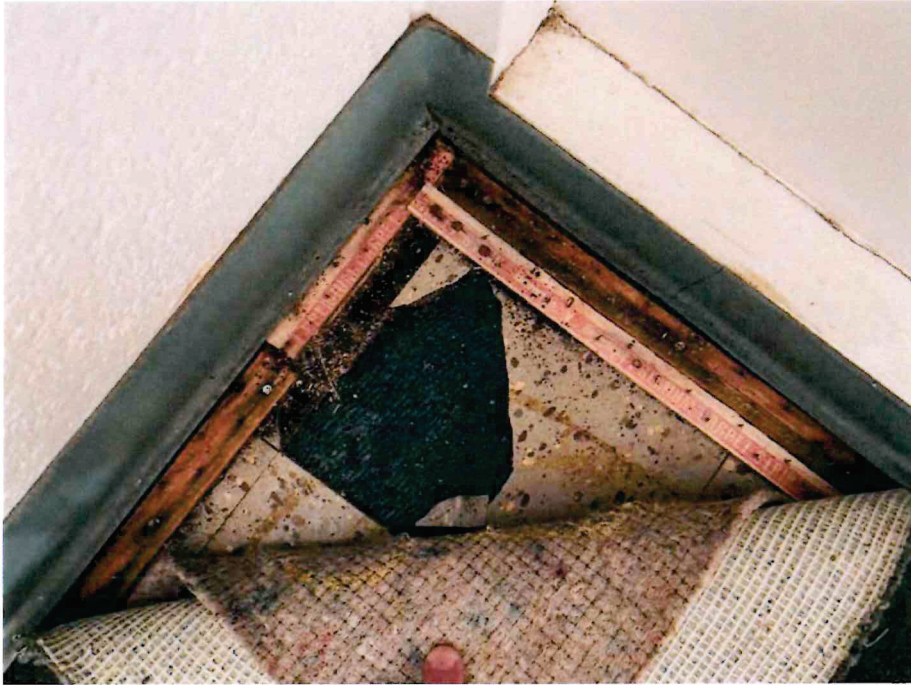
**Photo 5- Gray Speckled 9" x 9" Floor Tile & Black Mastic (Under Carpet)-
2515 Main St.- CHC Office Area- ACM**

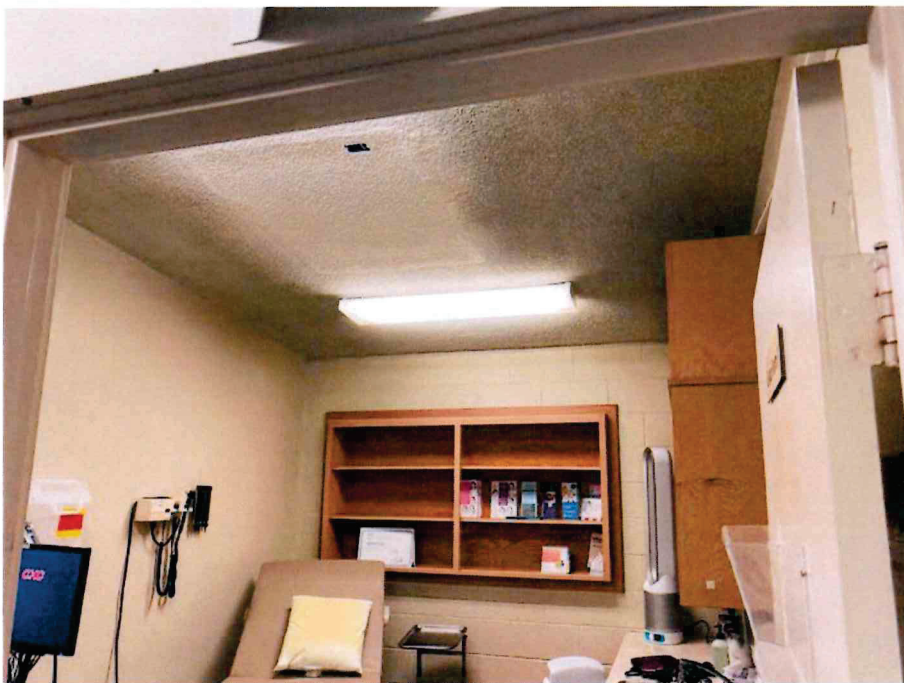
Photo 6- Spray-Applied Acoustic Ceiling Material- CHC Office Area- ACM

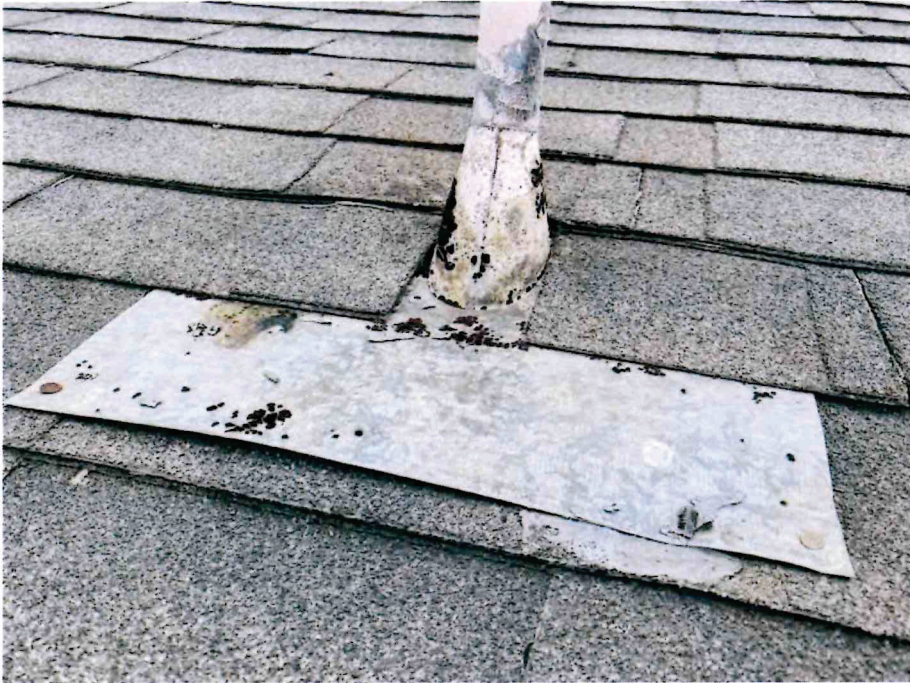
Sample(s)	Location	Type of Material	Level of Asbestos	Quantity	Friability	Condition
04, 05 & 06	Penetrations Throughout Roof	Roofing Mastic	10% Chrysotile	10 SF	Non-friable	Good

Photo 7- Roofing Mastic- 2535 Main St.- Penetrations Throughout Roof- ACM

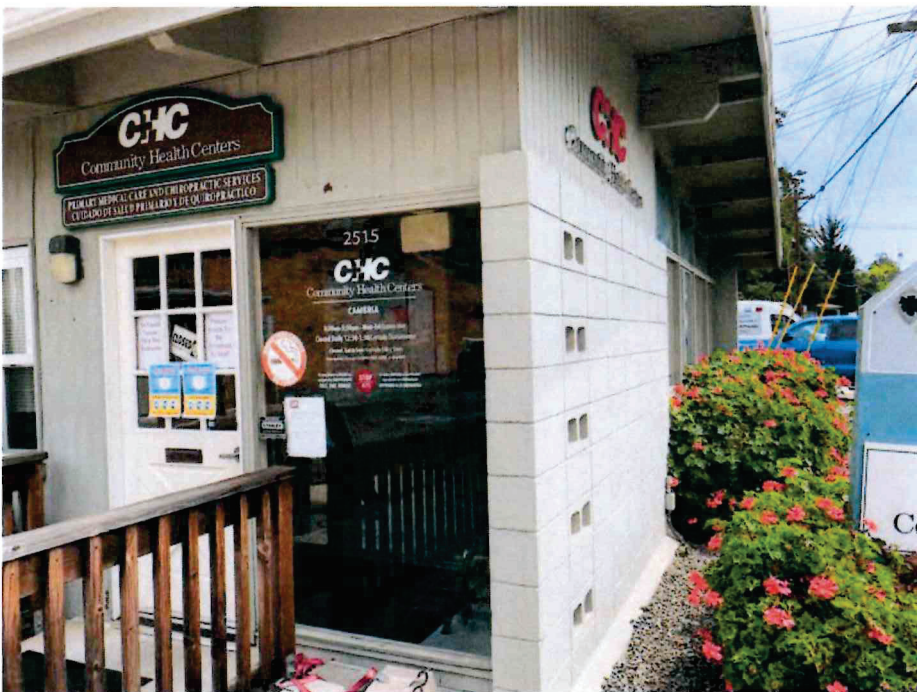
Photo 8- Gray Wood Window Casing/ Sill & Gray Wood Siding- 2515 Main St.- Exterior- LBP & Lead-Containing Paint(Poor Condition)

Detectable amounts of lead were found throughout the interior and exterior of the buildings. Confirmed lead-containing paint and LBP were in overall good to poor condition at the time of the survey. McKenna Environmental, Inc. recommends that all future activities that could disturb the lead-containing paint, including renovation or demolition, be performed by properly trained personnel. These activities should employ state-of-the-art techniques and be performed in accordance with all local, State, and Federal laws and regulations.

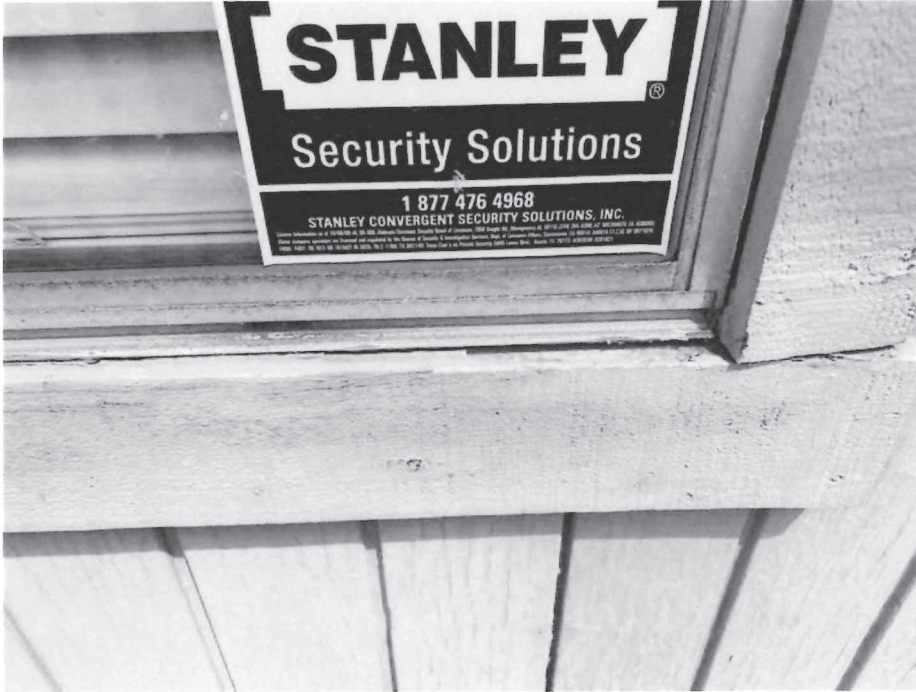
**Photo 9- Gray Wood Trim & Siding- 2515 Main St.- Exterior-
Lead-Containing Paint (Fair Condition)**

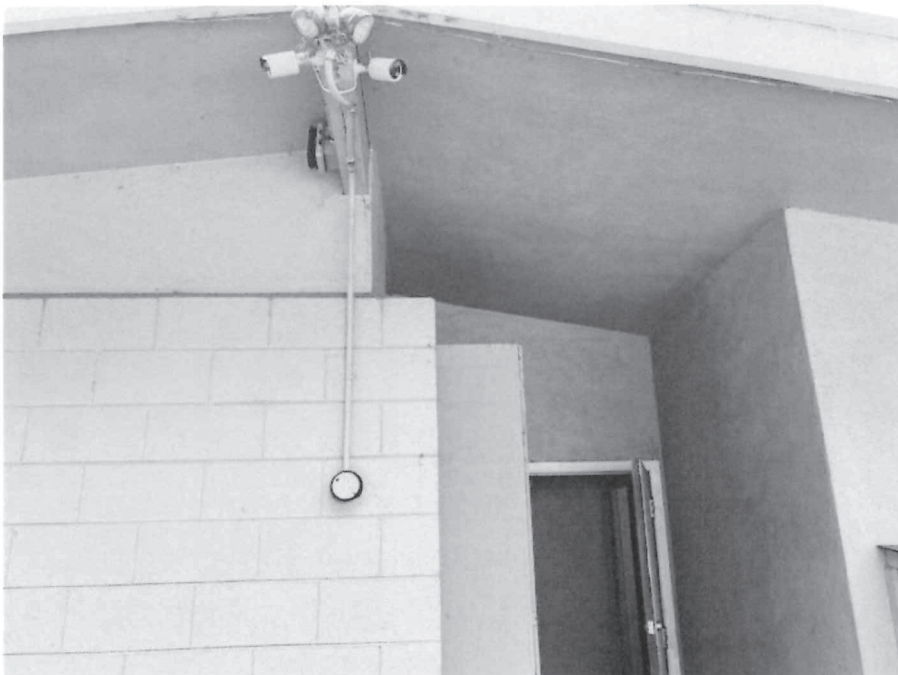
**Photo 10- White Wood Fascia- 2515 Main St.- Exterior-
Lead-Containing Paint (Good Condition)**

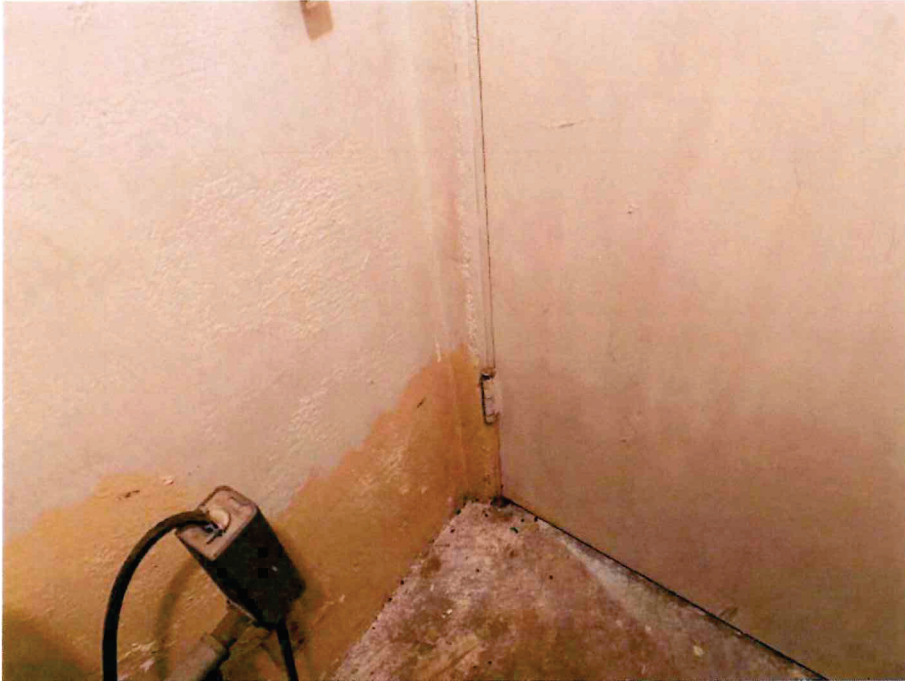
**Photo 11- White/ Yellow Plaster Wall- 2515 Main St.-
CHC Area- Lead-Containing Paint (Good Condition)**

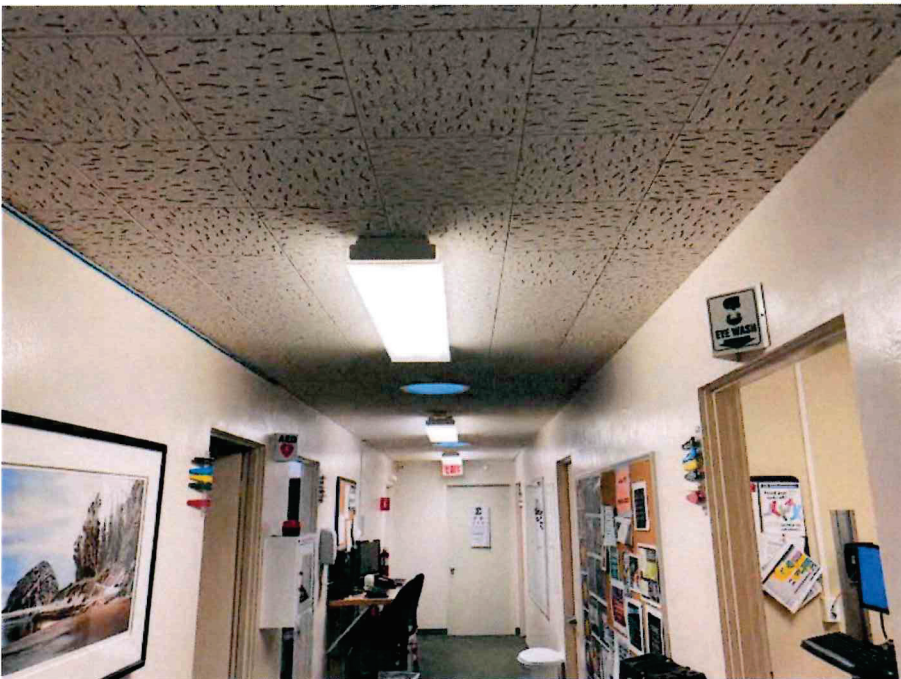
**Photo 12- White Plaster Walls, White Wood Door & Casing- 2515 Main St.-
CHC Area- Lead-Containing Paint & LBP (Good Condition)**

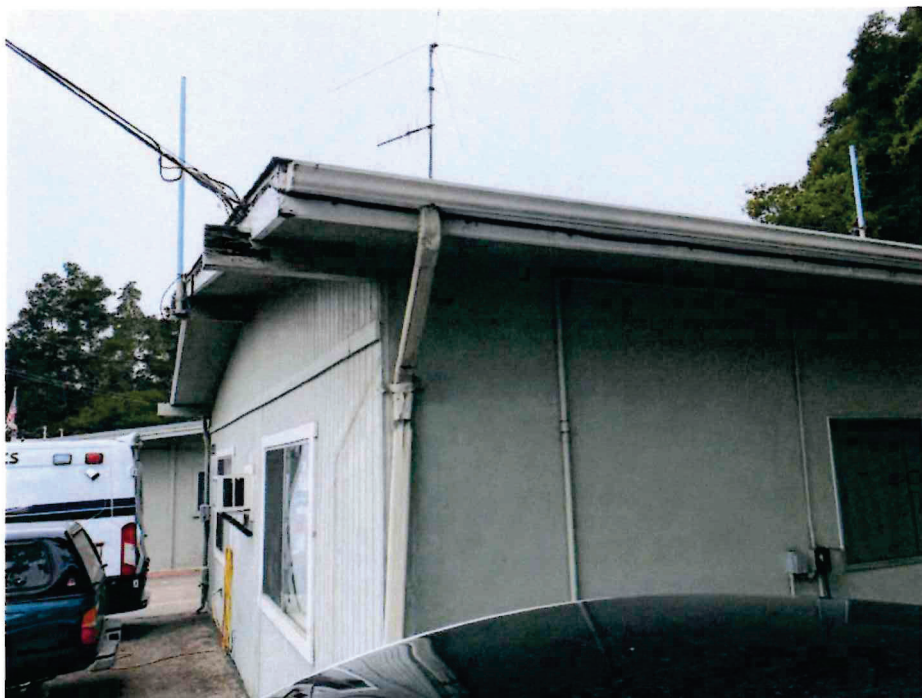
Sample	Location	Type of Material	Level of Lead	Condition
L-01	Exterior	Gray Wood Beam	0.10%	Poor
L-02	Exterior	White Wood Fascia	0.15%	Good- Fair
L-03	Exterior	White Wood Door Casing	0.098%	Good

There is a window-mounted air conditioning unit in the garage that has coolant that should be properly discharged.

**Photo 13- Gray Wood Beam & White Wood Fascia & Window-Mounted Air Conditioner
2535 Main St.- Exterior- Lead-Containing Paint & Refrigerant (Good- Poor Condition)**

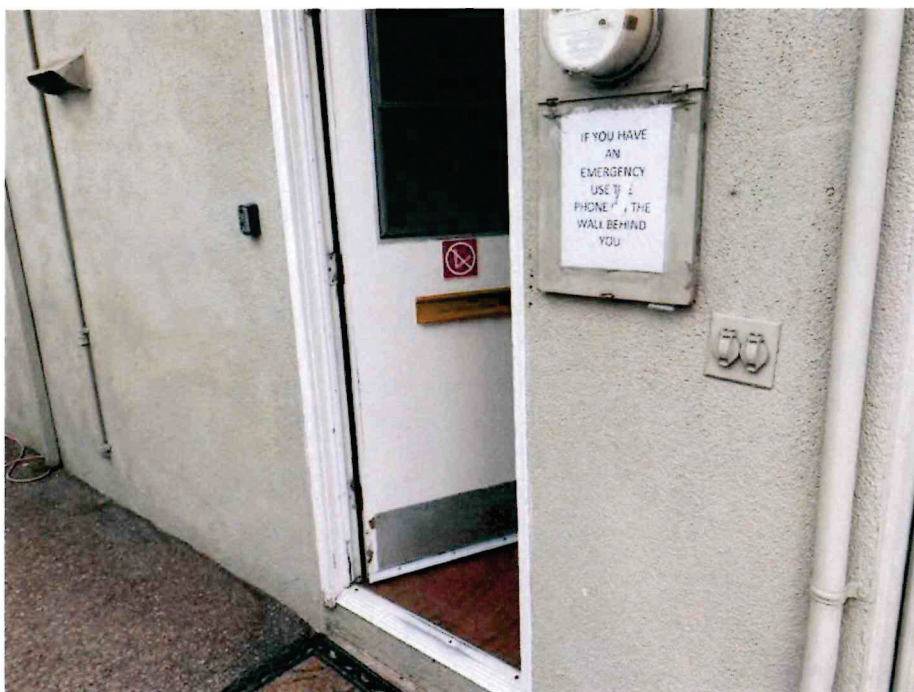
**Photo 14- White Wood Door Casing- 2535 Main St.- Exterior-
Lead-Containing Paint (Good Condition)**

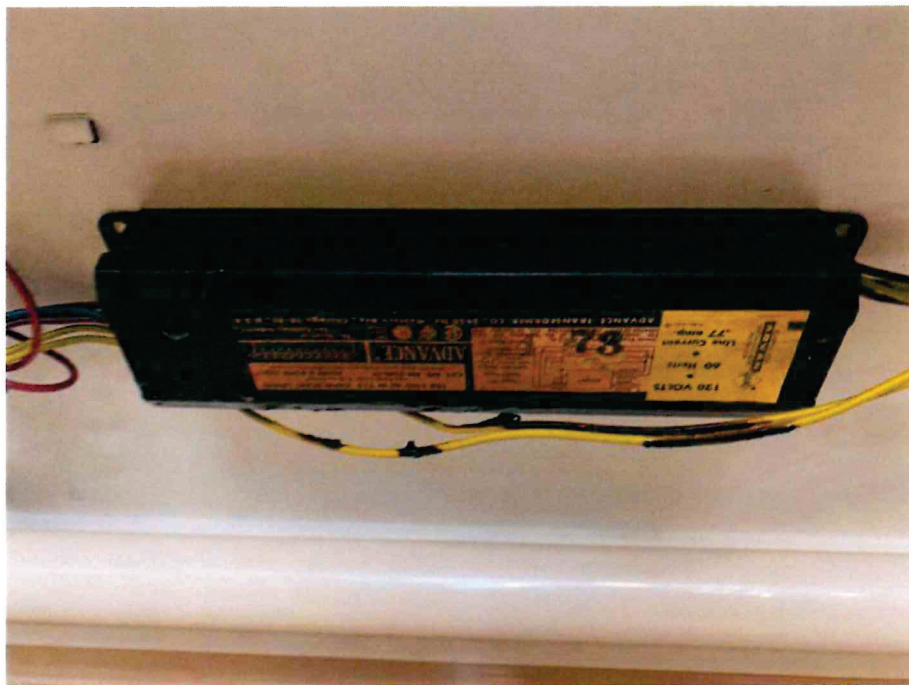
Photo 15- PCB Ballasts in Light Fixtures- 2515 Main St.- Throughout Area

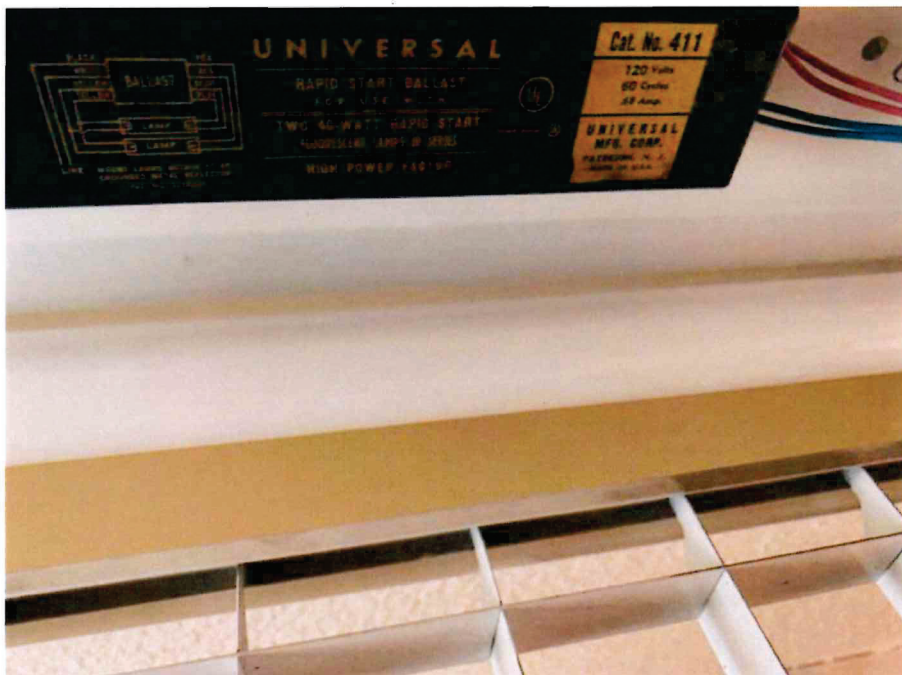
**Photo 16- Mercury-Containing Light Tubes in Light Fixtures-
2515 & 2535 Main St.- Throughout Area**
