Cambria Community Healthcare District
2535 Main Street, Cambria, CA

Facility Condition Assessment & Report

Orry Nottingham PE CAP Inc.

November 8, 2021

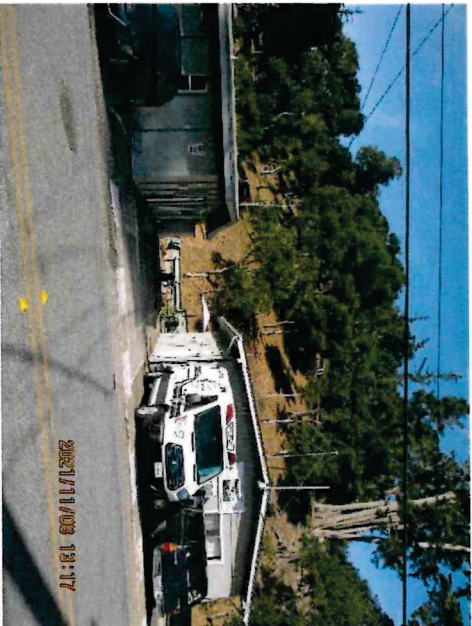
As you can see in above Photo 1. View from Main Street Vehicle Garage building, a rather steep hill can be seen in the photo (upper left NW corner) which is above the condemned Vehicle Garage building.

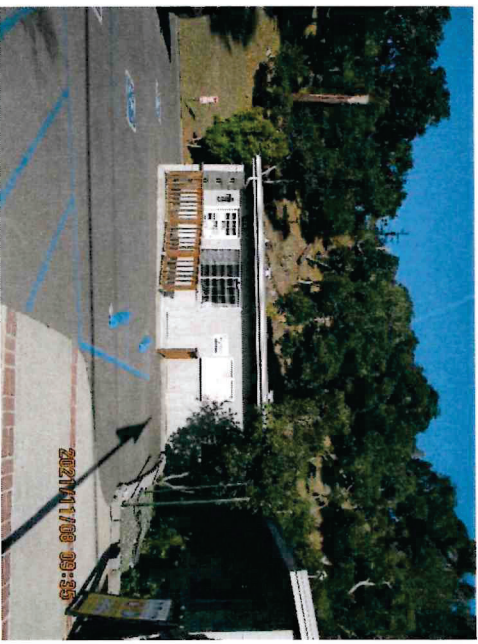
Photo 4. View from Parking Lot to Office

From this view can be seen the four PG&E electric service laterals (upper right), and water service meter and backflow preventer (lower right), and a gas service pipe and regulator (far back lower SE corner of building).

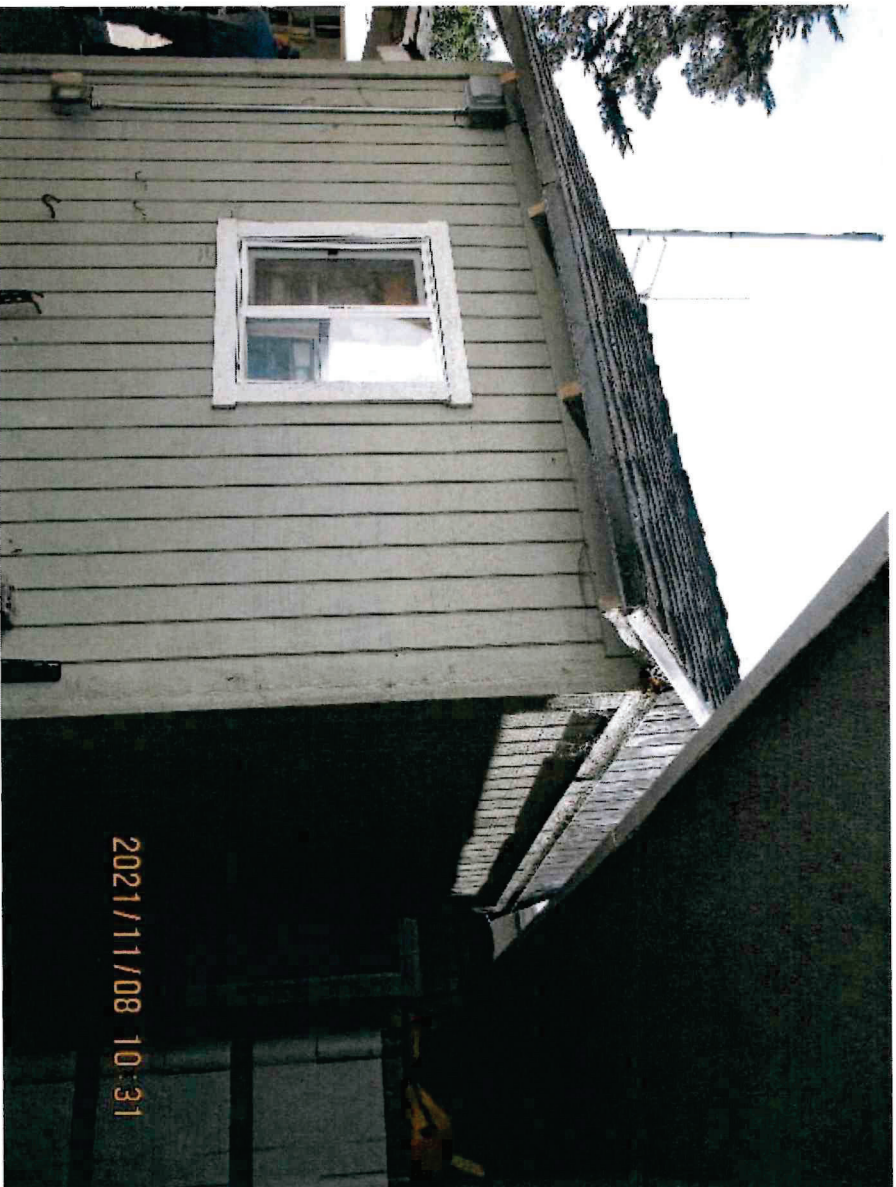
Photo 4.1. View of abandoned condemned Vehicle Garage due to conditions and proximity to the steep hill above the garage.

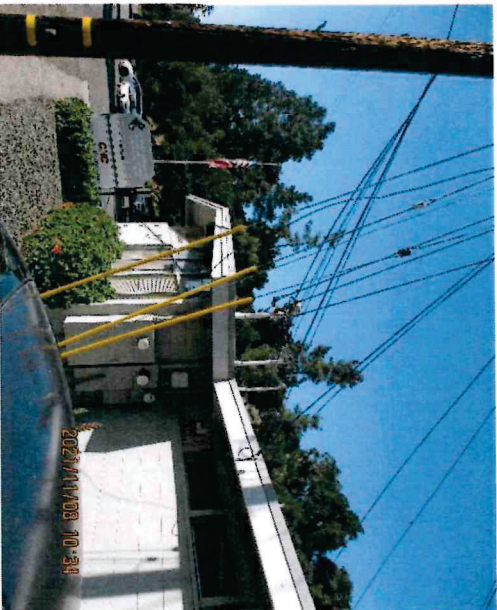
Photo 5. PG&E Laterals for four (4) Services

Multiple service laterals are observed noncompliant with National Electric Code (NEC) Article 250 Grounding and Bonding, and ARC-flash protection. Observe no grounding electrode conductors for building secondary power distribution panels.

(4) Recommend for any future PG&E service connection to replace (E) four service laterals with a single new underground primary service.

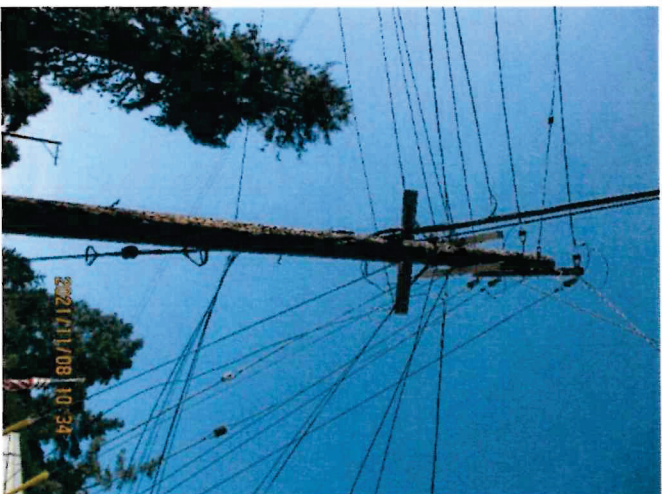
Photo 6. PG&E Electric Service Pole

Power lines shown above demonstrate insufficient power reliability and quality versus best practice public utility power service underground. Recommend existing 120/240Volt Single Phase, 3-Wire power be demolished. Suggest new underground laterals, transformer and switchgear rated 480/277 Volt, 3-Phase, 4-wire system.

The Cambria Community Healthcare District provides a critical public fire-life-safety type service mission, and recommend PG&E utility likewise, should demonstrate a best practice to mitigate risk of interruption in service, replace the hodge-podge existing observed obsolete power pole, transformer and multiple connected loads.

Recommend PG&E provide upgrade of future service with a compliant 12-15KV, 3-phase delta power system, and transformer service with Main Switchgear rated 1200Amp, 480/277Volt, 3-phase, 4-wire power system. This recommendation applies to any new project planned for this site to replace the existing obsolete building and facilities.

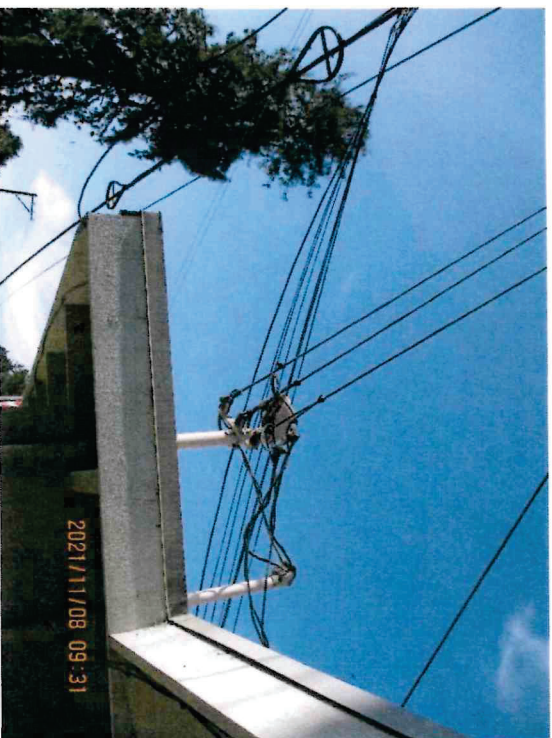
Photo 6.1 Utility Electric Service Pig-tails and Hodge-podge wiring

NEC Section 230.2 guidelines define service to a single service entrance connection.

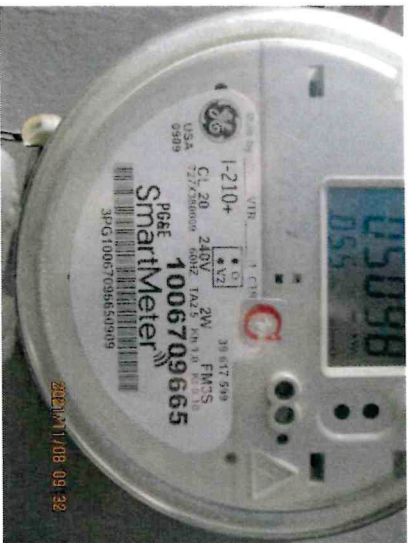
Photo 8. Multiple PG&E Meters (1 of 4 meters)

Multiple meters, inadequate panelboards, suspect over current protection, grounding and sizing of conductors, breaker set points, interrupting fault current ratings. Power distribution equipment overall is obsolete and non-repairable. Low voltage wiring is deficient including grounding, routing, labeling, circuit identification, and connections are observed holistically non-compliant and at risk of cross connections throughout.

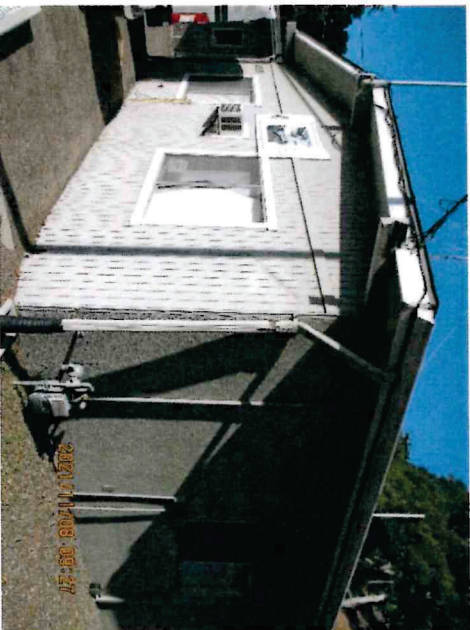
Photo 13. PG&E Gas Service Entrance

In Photo's 13, and 14, the gas service is inadequate, such as pipe route, protection, regulator type, size, and function. Pipe is routed on outside of building, no turnoff valves, no safety devices, and no identification.

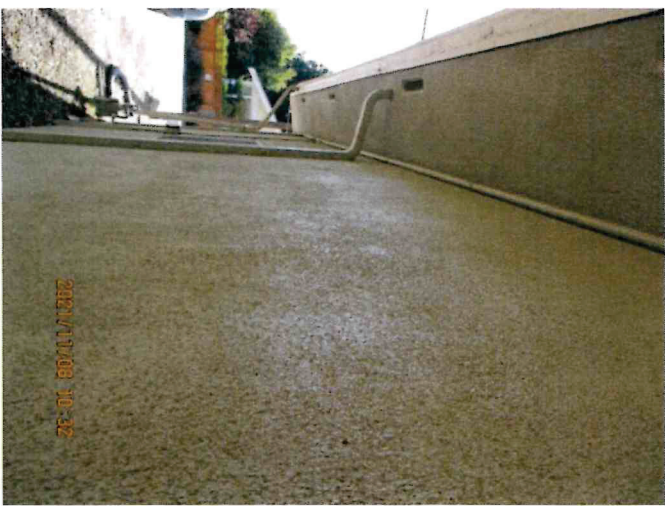
Photo 16. Gas Line Installed below Roof overhang

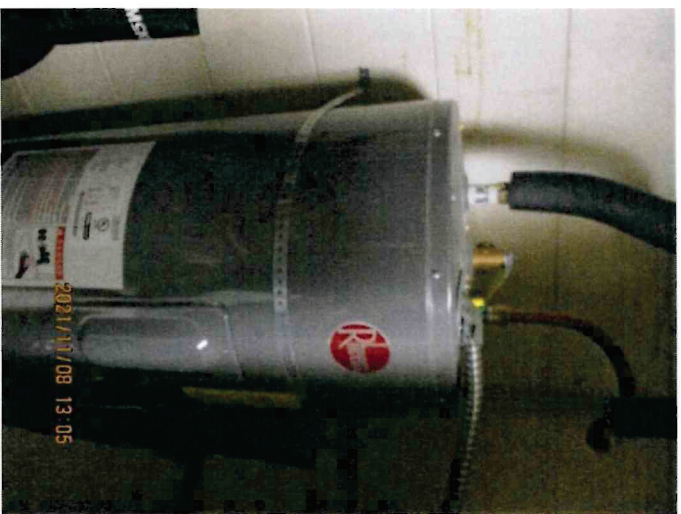
Gas was used to serve a gas hot water heater, which appears to be disconnected, and replaced by electric water heater located in the building. The old gas connected remains as observed with potential risk of a gas leak.

Photo 18. (N) EWH Replaced old gas DWH

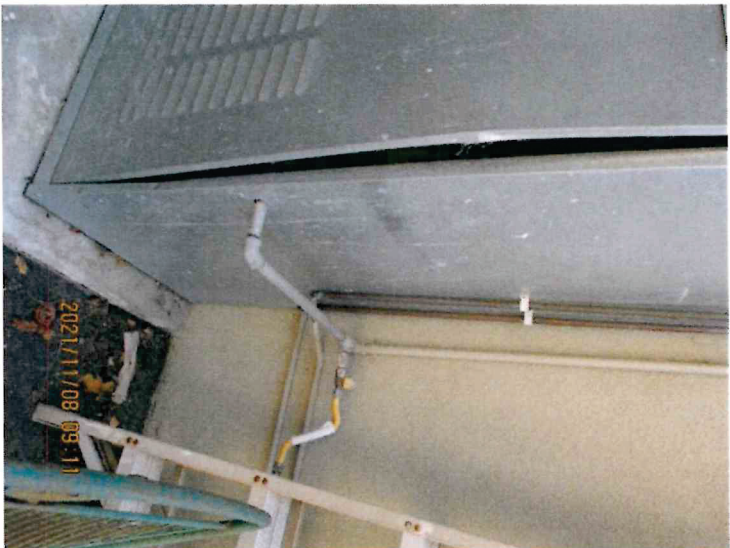
Photo 19. Non-compliant Gas connection

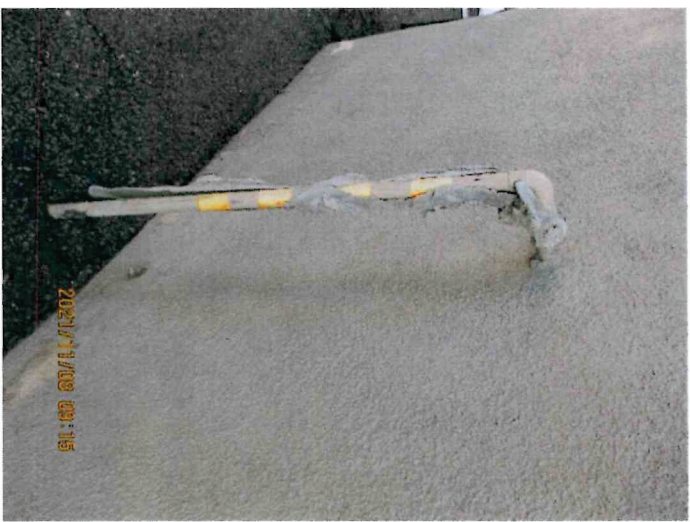
Photo 20. Unidentified Gas Line

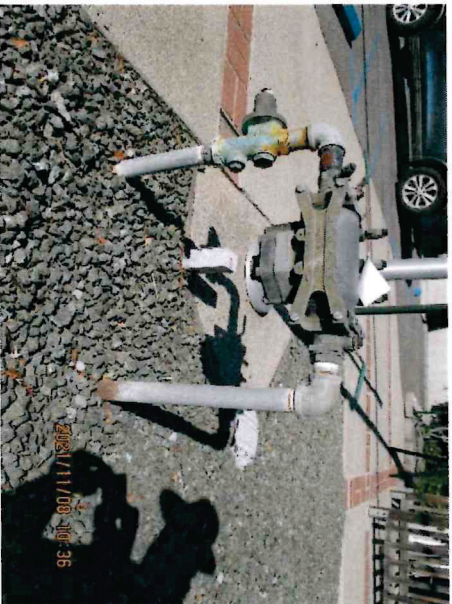
Photo 21. Domestic Water Backflow Preventer

Water Service connection include water meter and backflow preventer located at the parking lot to west of the building lobby. No evidence of regular backflow testing and certification is observed.

Recommend a water quality testing and report for the domestic water service. A water softening treatment system may have been noticed during the brief spot checks of building domestic water plumbing fixtures at the building break room and toilet rooms. Evidence of mice intrusion was also observed.

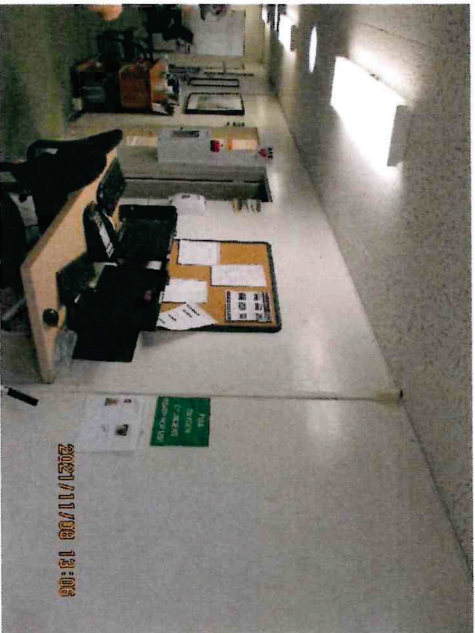
Photo 23. Example Building Interior Hallway

Communications wiring in Photo 23, is observed installed at the upper corner of the Hallway. This location for cable installation was due to reported hazardous material present above ceiling in plenum area, which was reported to be non-accessible due to hazardous materials present above the ceiling.

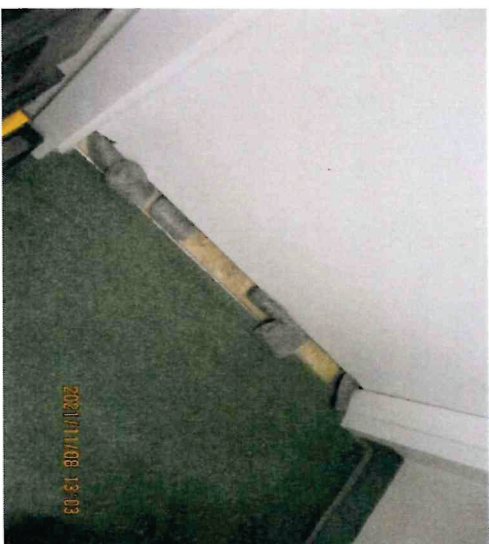
Photo 24. Steel Wool Placed Under Door

The steel wool is observed under the door in Photo 24, which was reported placed there, which helps to keep the mice away from intrusion as mice will not eat the steel wool material, which is reported as an on-going issue.

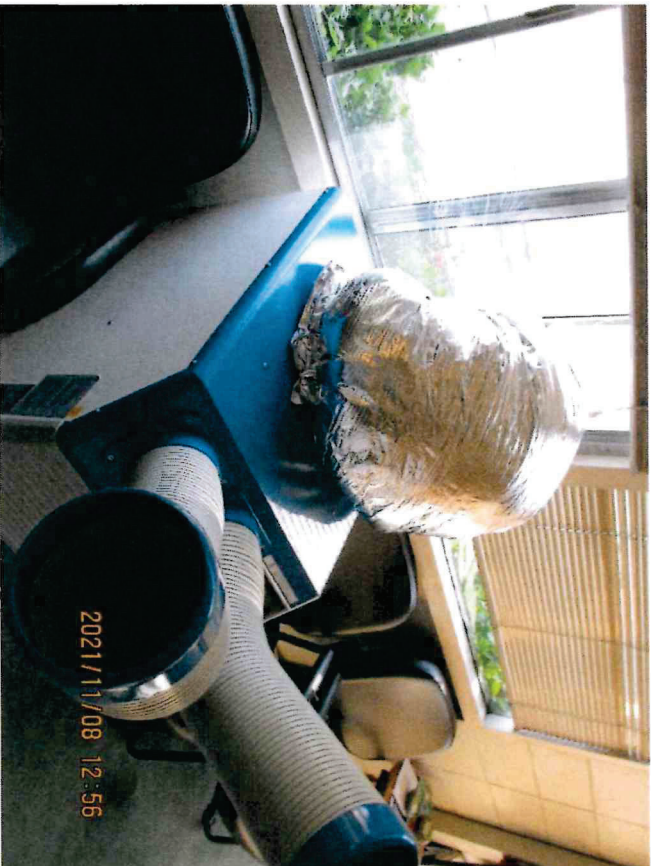
Photo 25. A Portable Evaporative Cooler – One for the Whole Building

In Photo 25, a single evaporative cooler is observed at the Lobby area, which purpose is to provide cooling fresh air throughout the building... one such unit is insufficient to provide the whole building indoor air and climate control throughout occupied areas. At hallways and the Lab area, little to no air flow was observed.

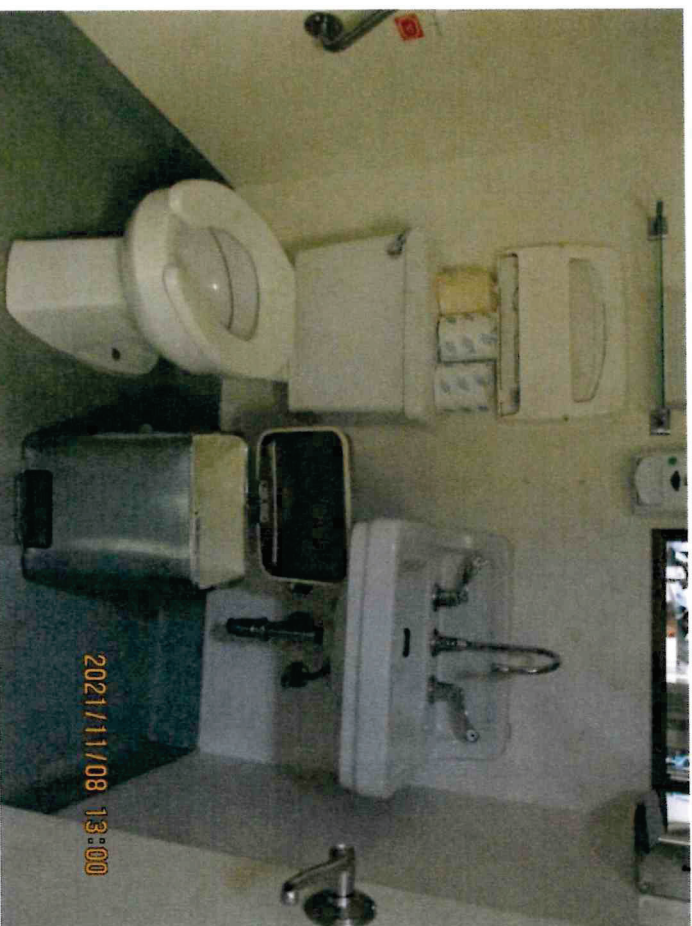
Photo 27. Non-compliant Toilet facilities - no exhaust, no ventilation, and ADA non-compliant.

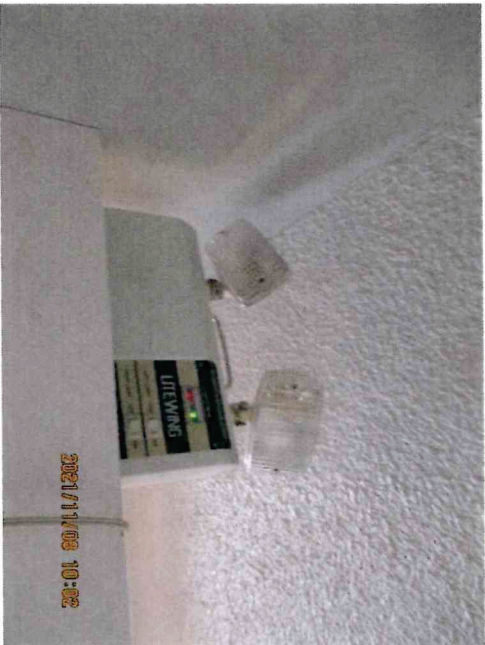
Photo 28. Emergency lighting. HAXMAT materials above

Observe branch power distribution and emergency lighting is inadequate and non-repairable throughout. Any new scope of work or repairs to mitigate observed issues – would be considered a waste of resources. Wiring issues and overall circuitry and points of connection are obsolete, past any service life cycle, and non-repairable.

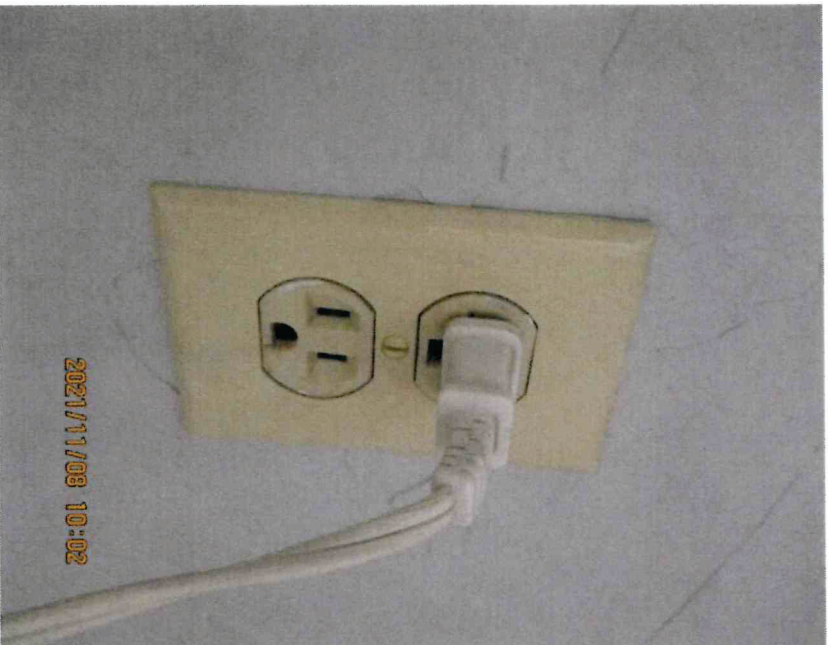
Photo 29. Non-compliant branch circuits and outlets

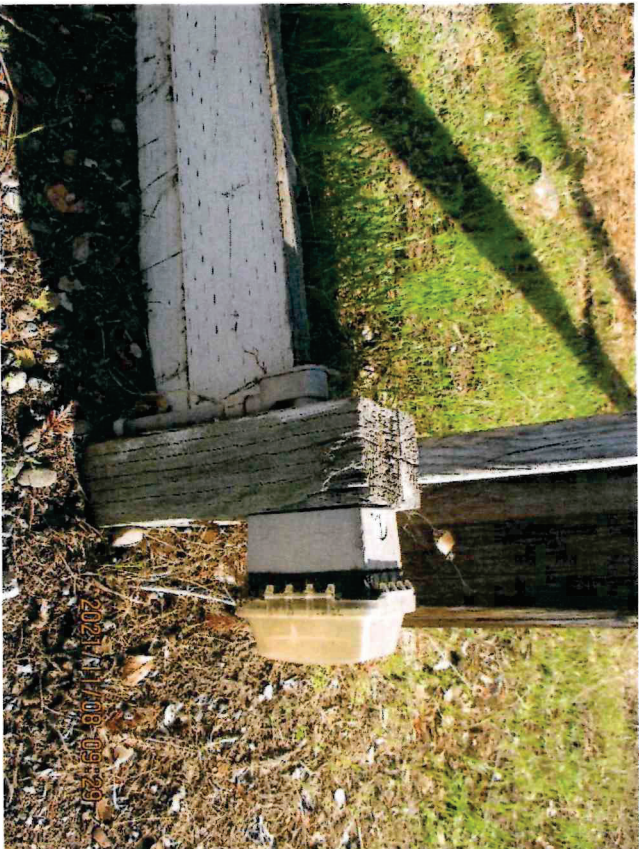
Photo 30. Non-compliant Exterior Convenience Outlet

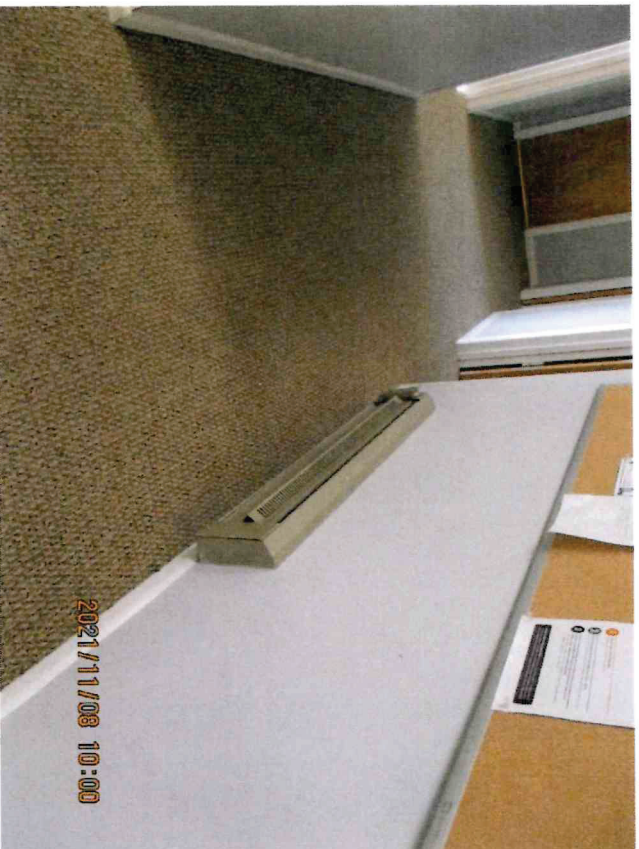
Photo 31. Example of Interior Non-operable Wall-mount Baseboard Heaters

In Photo 31, an obsolete baseboard radiator is observed. No building heating is provided. Occupants bring their own portable heaters to occupied spaces as needed. Numerous breaker interruptions occur routinely.

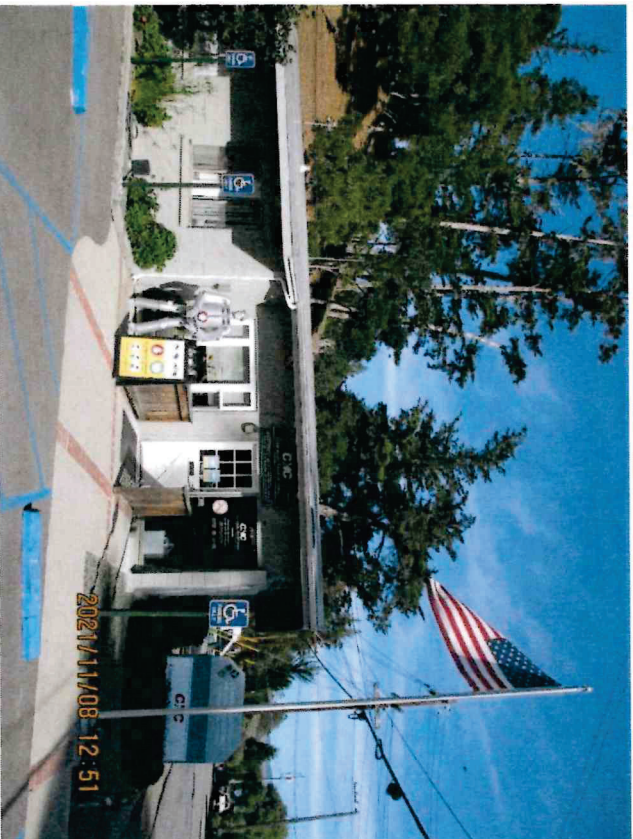
Photo 32. Cambria Community Healthcare District Services Facility

In Photo 32, the front office lobby is observed to right of the *Tin-Man* with temporary portable evaporative air-conditioner protruding out the window facing Main Street. No building central air-conditioning, or building heating is provided. Occupants bring portable heaters, when needed. There is no central ventilation.
