Cambria Community Healthcare District
2535 Main Street, Cambria, CA

Facility Condition Assessment & Report

Orry Nottingham PE CAP Inc.

November 8, 2021

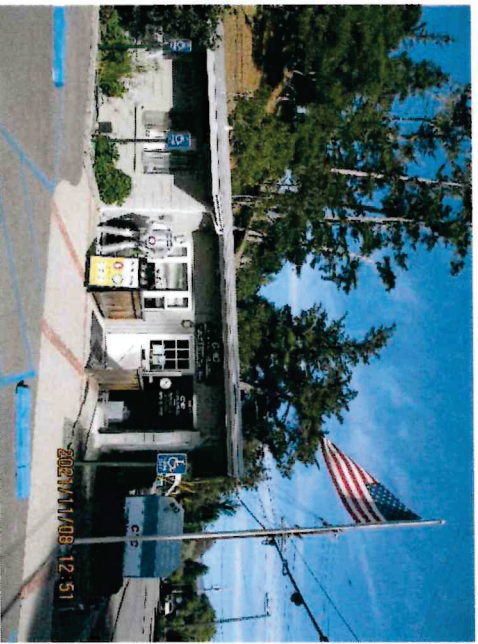
Photo 3. View from Parking Lot to Lobby

The front lobby includes a single portable water source evaporative cooler, which attempts to provide a whole building cooling and ventilation that is woefully inadequate. Essentially, no operating heating, cooling, and/or ventilation results in poor indoor air quality, which is observed inadequate and non-compliant.

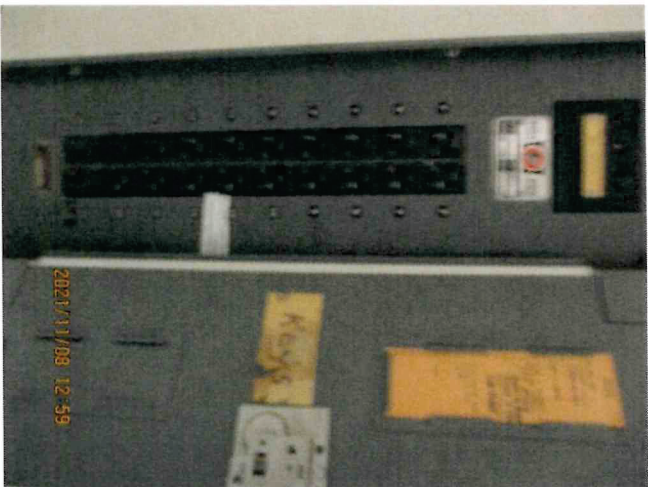
Photo 11. Power Distribution Panelboard #2

Multiple meters, inadequate panelboards, suspect over current protection, grounding and sizing of conductors, breaker set points, interrupting fault current ratings. Power distribution equipment overall is obsolete and non-repairable. Low voltage wiring is deficient including grounding, routing, labeling, circuit identification, and connections are observed holistically non-compliant and at risk of cross connections throughout.

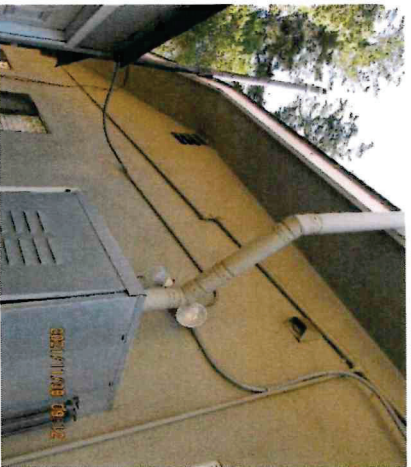
In Photo's 13, and 14, the gas service is inadequate, such as pipe route, protection, regulator type, size, and function. Pipe is routed on outside of building, no turnoff valves, no safety devices, and no identification.

Gas was used to serve a gas hot water heater, which appears to be disconnected, and replaced by electric water heater located in the building. The old gas connected remains as observed with potential risk of a gas leak.

Photo 17. Gas Line Runs on side of building to DWH

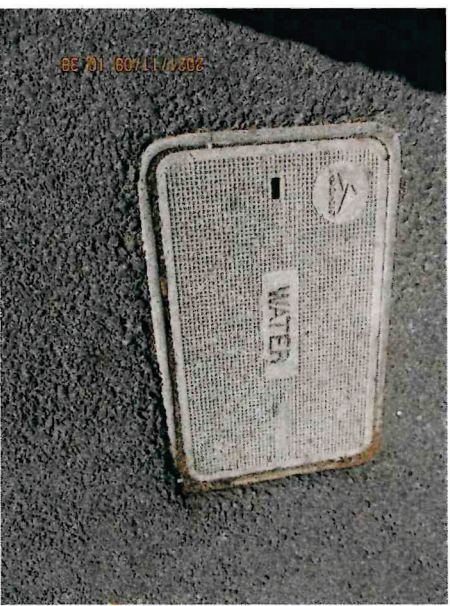
Photo 22. Domestic Water Meter

Water Service connection include water meter and backflow preventer located at the parking lot to west of the building lobby. No evidence of regular backflow testing and certification is observed.

Recommend a water quality testing and report for the domestic water service. A water softening treatment system may have been noticed during the brief spot checks of building domestic water plumbing fixtures at the building break room and toilet rooms. Evidence of mice intrusion was also observed.

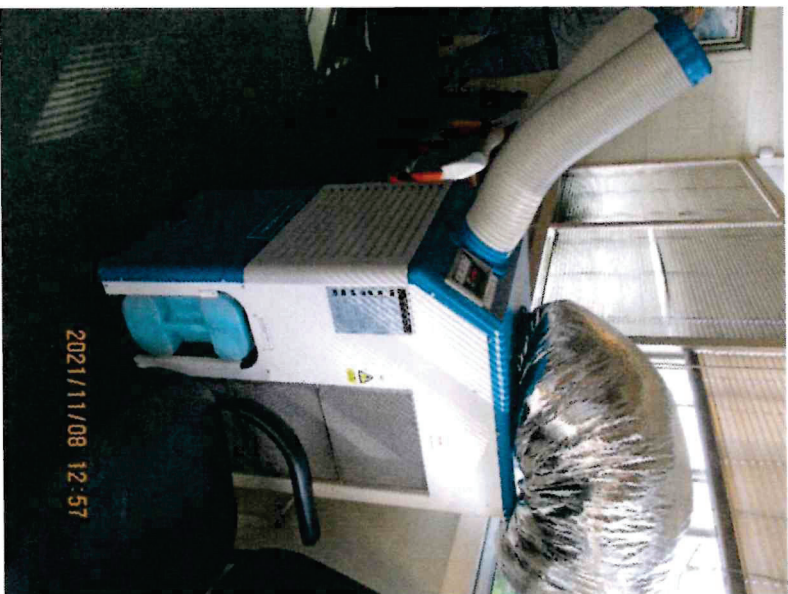
In Photo 25, a single evaporative cooler is observed at the Lobby area, which purpose is to provide cooling fresh air throughout the building... one such unit is insufficient to provide the whole building indoor air and climate control throughout occupied areas. At hallways and the Lab area, little to no air flow was observed.

Photo 26. Evaporative Cooler at Lobby Entrance
